FIELD REPORT

Assessment: Eleven La Sal Mountain Springs, August 9-11, 2016

Grand Canyon Trust

September 2016

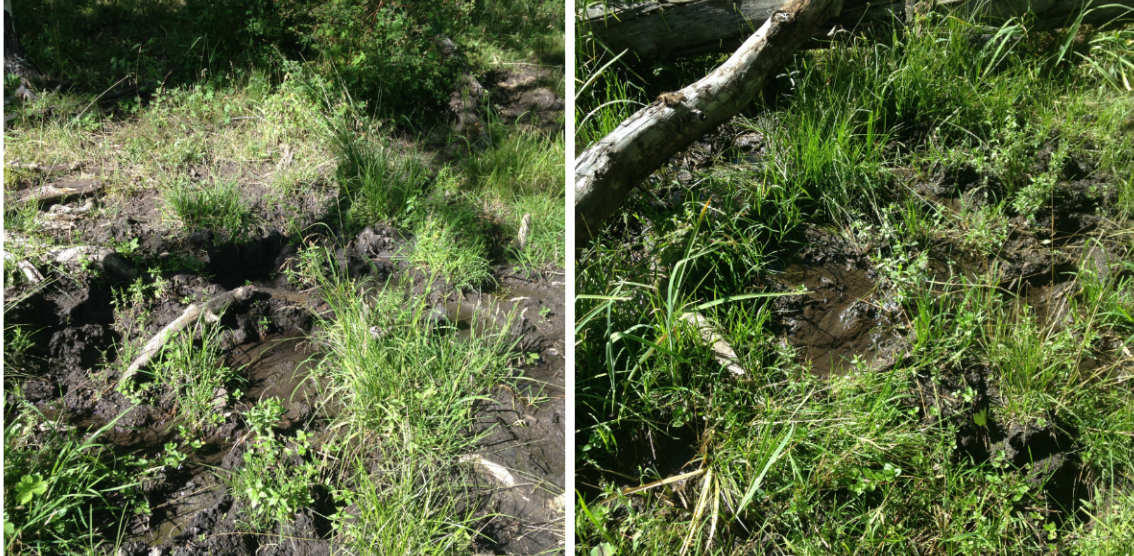
Water presence: Surface water was present in small areas but no flow was detected. Trampling was present in the surface water areas.

Photograph Set 1 (August 9, 2016) –Trampling was present in wettest portion of exclosed area at North Hollow Aspen Spring #1.

- The enclosure did not protect all of the willow shrubs at the spring site. We recommend that it be expanded to include additional willow protection.
- The bottom wire of the enclosure fence was barbed and was only a few inches from the ground in some areas. We recommend that this bottom wire be raised and changed to smooth wire to reduce access challenges for wildlife.

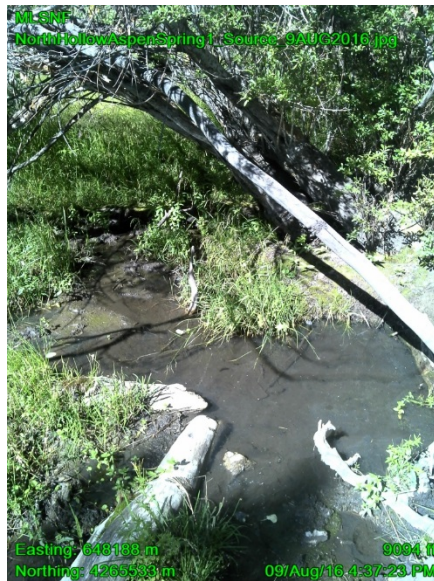
Photograph 2 (August 9, 2016) – Presumed source of North Hollow Aspen Spring #1. Photograph is georeferenced and indicated in the field map (Figure 1).

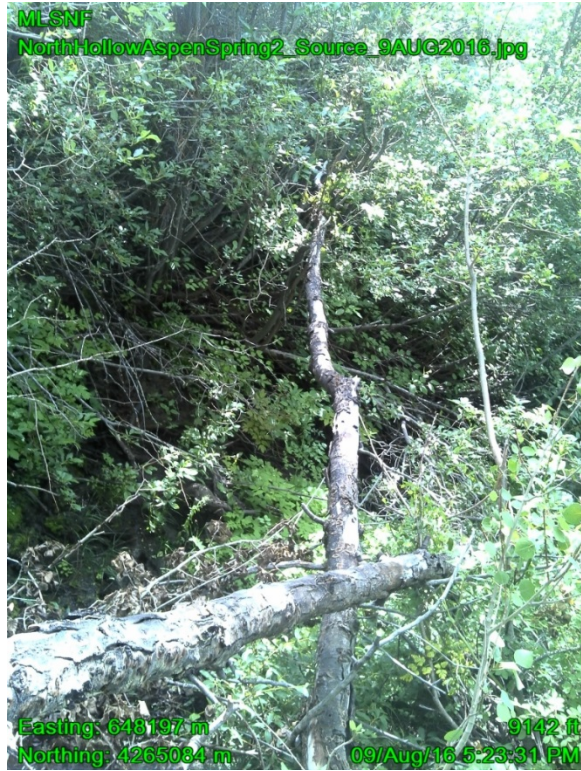
Photograph 3 (August 9, 2016) - Presumed source (bottom left, beyond branches) of North Hollow Aspen Spring #2. Photograph is georeferenced and indicated in the field map below (Figure 1).

- Similar to North Hollow Aspen Spring #1, this site was the focus of ongoing restoration which aimed to protect the primary riparian area from trampling with a recently-built enclosure. This enclosure was intended to reduce trampling in the riparian area moving forward. It should also provide an opportunity for aspen and willow recruitment as it protects from cow and elk browsing, which seemed to be a factor in the lack of regeneration and recruitment at this site.
- The bottom wire of the enclosure fence was barbed and was only a few inches from the ground in some areas. We recommend that the bottom wire be raised and changed to smooth wire to reduce hazardous access for wildlife.
- Non-native grasses were present at the site and should be a focus for managers into the future. We encourage managers to research and apply site-appropriate methods where possible.

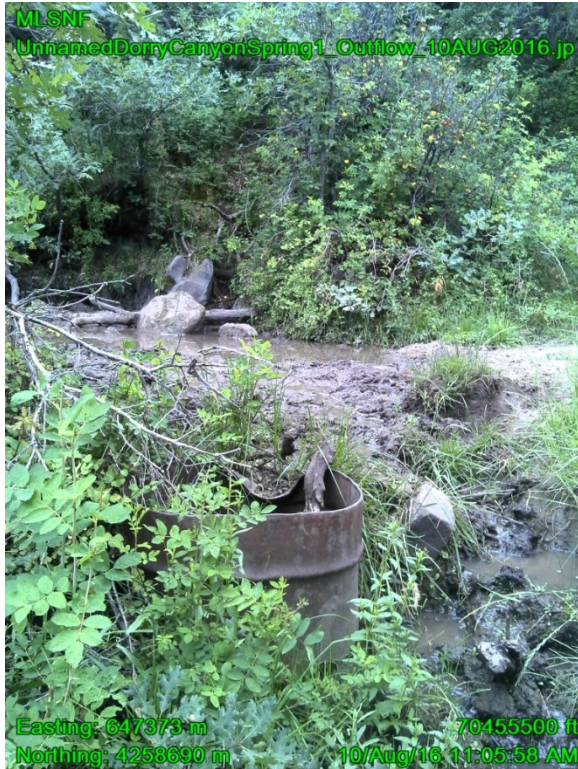
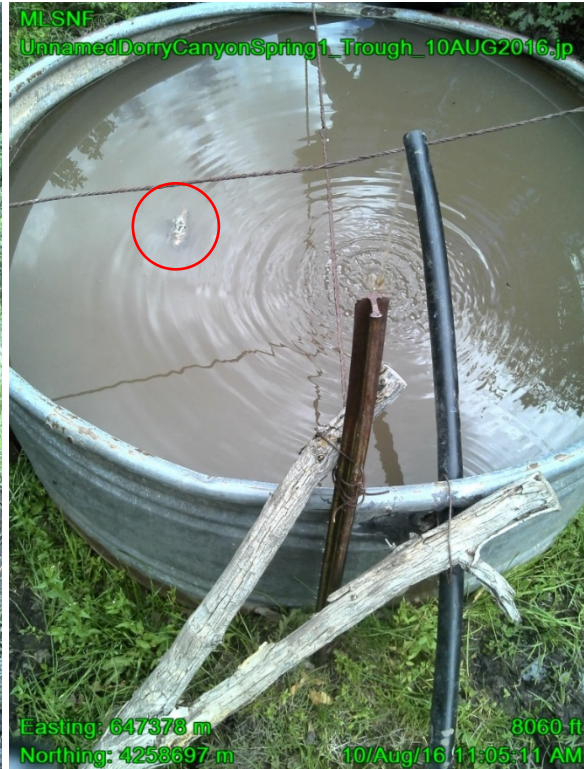
Water presence: Water was present as both surface water on access road and as a steady moderate flow out of a pipeline into a trough. Some overflow from the trough was present and creates additional surface water, although much trampling was present in these wet areas around the trough.

Water infrastructure: A culvert, trough, and pipeline were present and functioning below/downslope of the road. Spring source was likely above/upslope of the road. The trough lacked a functional wildlife escape ramp.

Photograph Set 4 (August 10, 2016) - Spring water ran and pooled across road at Unnamed Dorry Canyon Spring #1 (left). Pipeline and trough at Unnamed Dorry Canyon Spring #1 (right). Trough was lacking adequate wildlife escape ramp, likely resulting in animal mortality (see small mammal mortality circled in red). Photographs are georeferenced and indicated in the field map (Figure 1).

- While the tethered tree branch might encourage some wildlife access, a lack of a submerged escape ramp created a hazard for wildlife. A dead ground squirrel was found floating in the trough (see photograph below) and was evidence of the need for an adequate wildlife escape ramp. The tree branch tethered to trough (in photograph below) could be a wildlife access ramp if modified to be partially submerged in the trough, touch the bottom of the tank, and have a portion of the ramp flush with the inside of the tank (as many stranded animals will swim the perimeter of a tank in search of escape and may go under an existing ramp if a portion of it is not flush with the inside wall of the tank). We recommend following the guidelines outlined in *Water for Wildlife Handbook for Ranchers and Range Managers*¹ for wildlife friendly cattle tanks and troughs.

- The pipeline and trough should be managed to control for overflow which encouraged erosion downslope of the trough. The pipeline and trough could be in use only seasonally when cattle are in the pasture and water could be left at the spring source during the off-season.

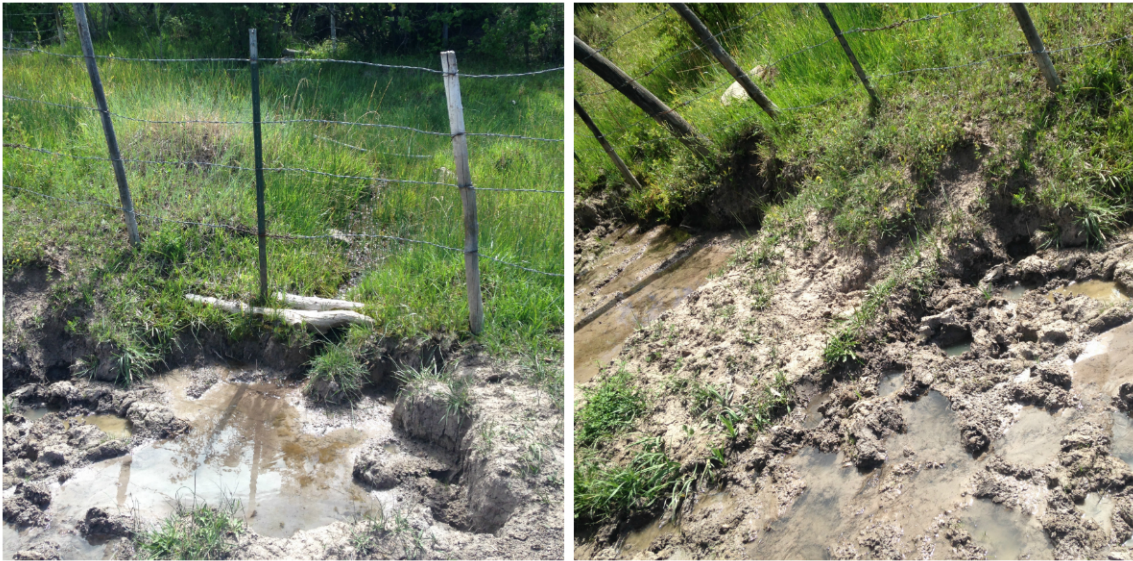
Water presence: Surface water was present as a steady flow down a drainage that ran across the access road. This flow joined another outflow likely from another spring source. The drainage continued above the fenced source along a wet meadow. Trampling was present throughout drainage and substantial trampling had occurred in the source runoff just outside of the enclosure fence.

Photograph Set 1 (August 10, 2016) - Runoff area from source at Unnamed Dorry Canyon Springs #2 had been trampled causing substantial erosion just outside the enclosure fence (left). This erosion was present along the fence, just beyond the runoff point (right).

At Unnamed Dorry Canyon Spring #2 substantial erosion was noted outside of the enclosure fence. The drainage between the upland wet meadow and downstream trough has the potential to become an incised channel over time if not monitored and managed.

- While the spring source was protected by an enclosure fence, the remainder of the wet meadow riparian area lacked protection. The enclosure fence could be expanded to include this unprotected area.
- Runoff from the source created a wet meadow area and erosion was substantial just outside of the enclosure fence (see photographs below). The enclosure fence could be expanded to include this protected area and/or the distance between the source and the cattle should be increased.

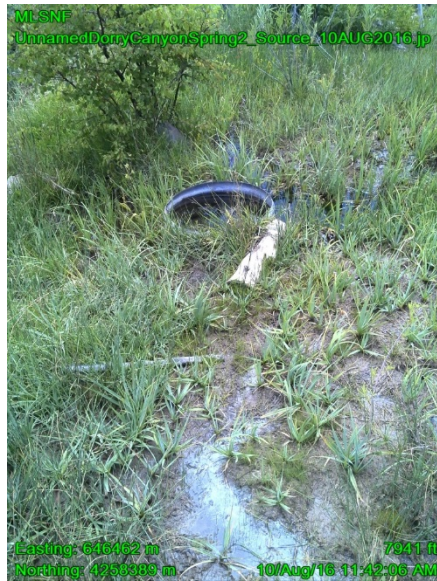
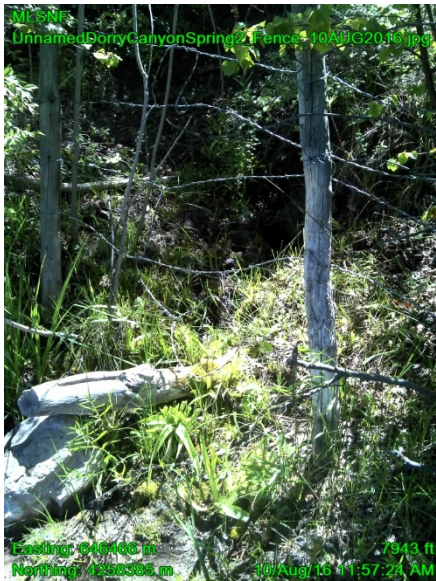
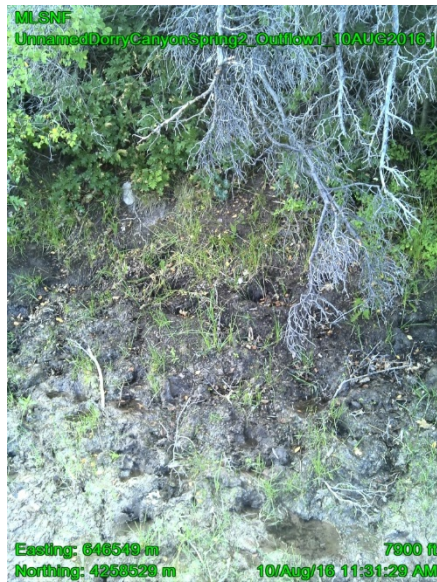
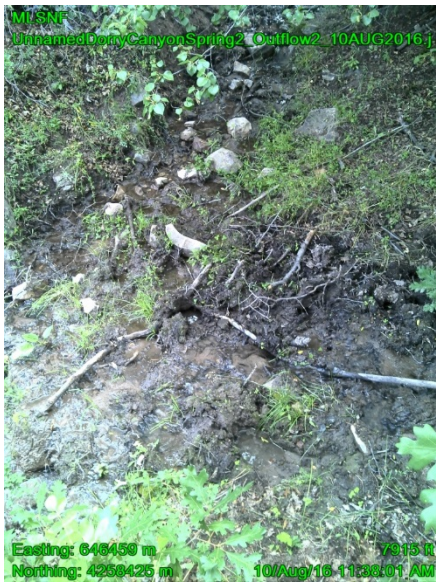
Photograph Set 5 (August 10, 2016) – Culvert source (top left), enclosure fence and runoff (top right), primary outflow from source (bottom left), and confluence of two outflows suggesting second source (bottom right) at Unnamed Dorry Canyon Spring #2. Photographs are georeferenced and indicated in the field map (Figure 1)

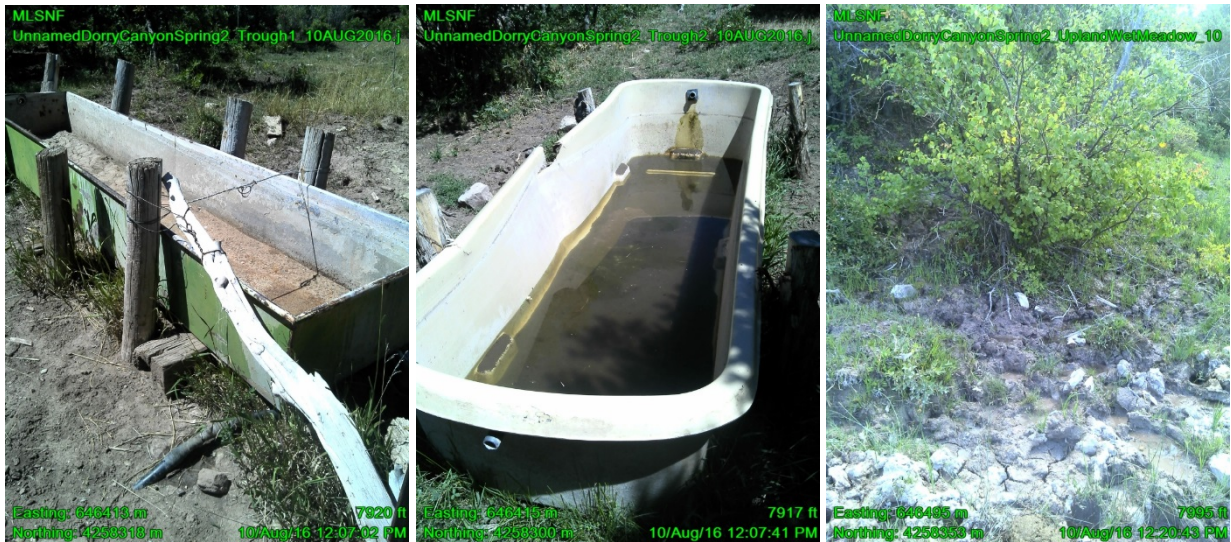
Water infrastructure: A pipeline was present at the spring source, which was developed with a culvert; but, it was unclear where pipeline led, if anywhere. Two troughs, one dry and one with some water, were located south of the spring source, but it was unclear how they were connected to the spring source. No adequate wildlife escape ramps were present in the troughs.

Photograph Set 6 (August 10, 2016) – Two troughs (left, middle) and upland wet meadow (right) at Unnamed Dorry Canyon Spring #2. Photographs are georeferenced and indicated in the field map (Figure 1).

- The troughs present at this spring site were lacking adequate wildlife escape ramps. Although no mortalities were detected, we recommend following the guidelines in the *Water for Wildlife Handbook for Ranchers and Range Managers*² for wildlife friendly cattle tanks and troughs.
- Non-native grasses were present at the site and should be a focus for managers into the future. We encourage managers to research and apply site-appropriate methods where possible.

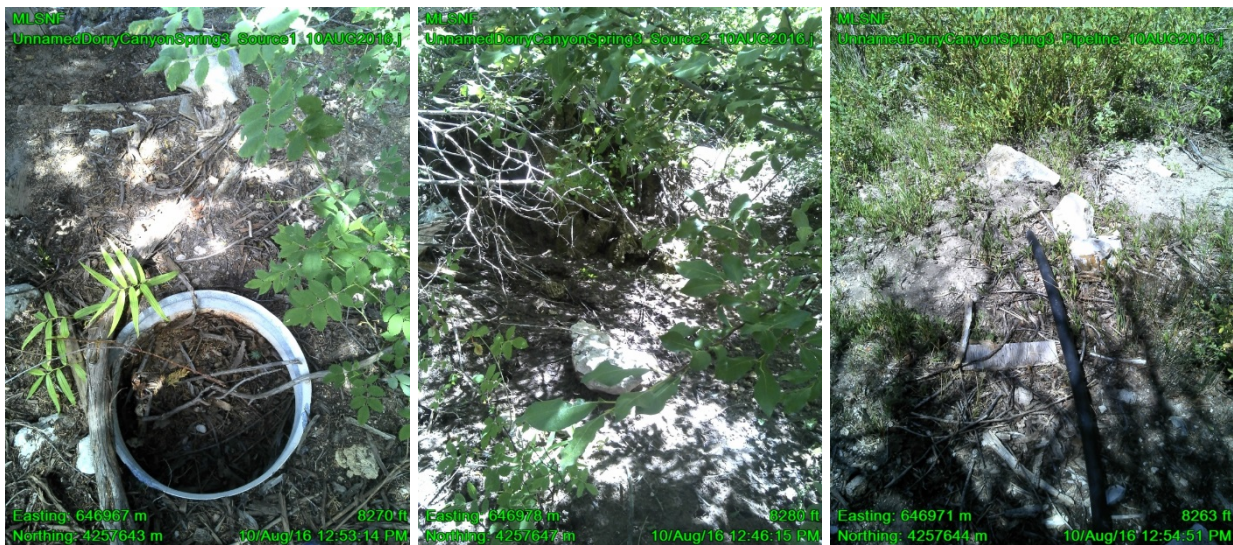
Photograph Set 7 (August 10, 2016) - Damp culvert source (left) with dry surroundings (middle) and pipeline (right) at Unnamed Dorry Canyon Spring #3. Photographs are georeferenced and indicated in the field map (Figure 1).

- The utility of the pipeline and culvert infrastructure at this spring site should be identified. If this infrastructure is not in use, it should be removed.
- Non-native grasses were present at the site and should be a focus for managers into the future. We encourage managers to research and apply site-appropriate methods where possible.

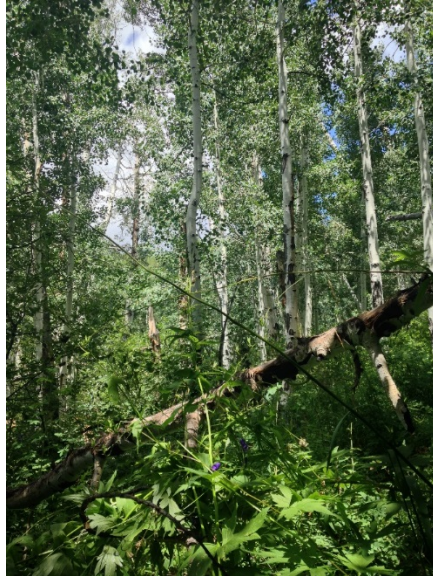
Photograph 8 (August 10, 2016) - Site photograph of dense aspen forest at Unnamed Dorry Canyon #4.

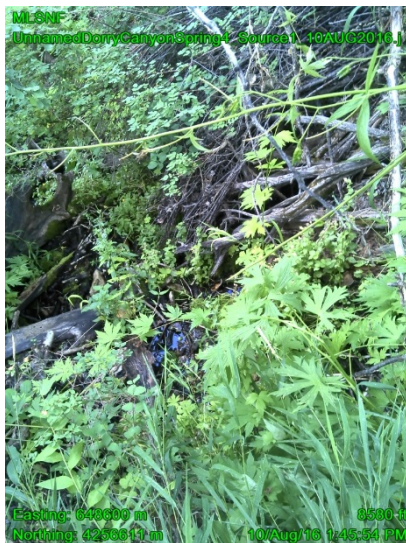
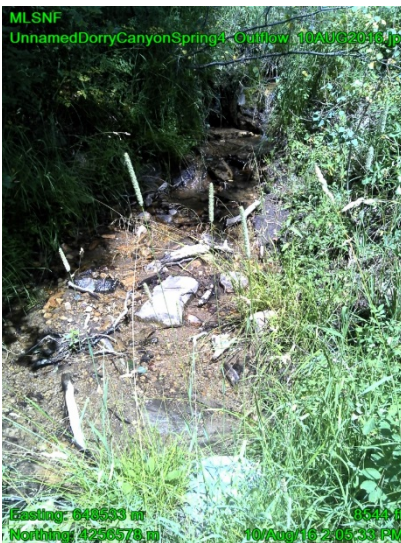
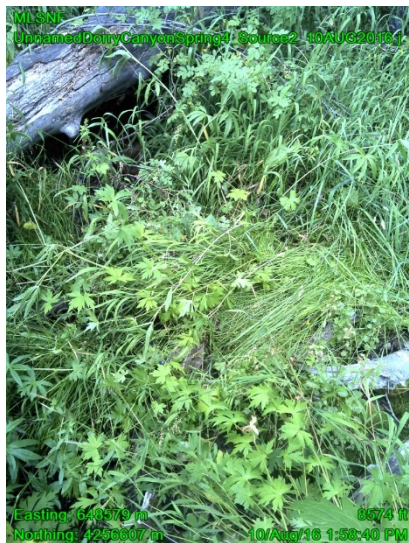
Photograph Set 9 (August 10, 2016) - Spring source (left) and outflows (middle, right) at Unnamed Dorry Canyon Spring #4. Photographs are georeferenced and indicated in the field map (Figure 1).

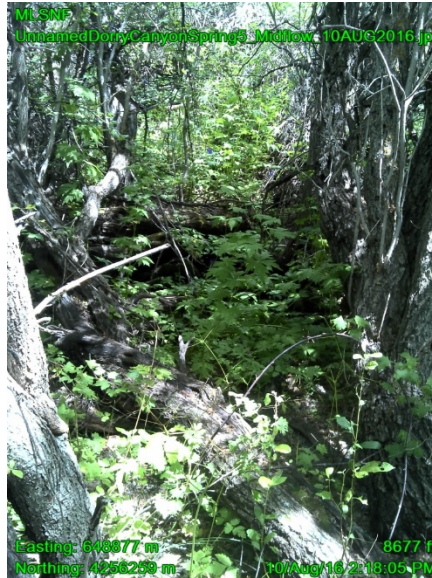
Photograph 10 (August 10, 2016) - Midflow at Unnamed Dorry Canyon Spring #5. Photograph is georeferenced and indicated in the field map (Figure 1).

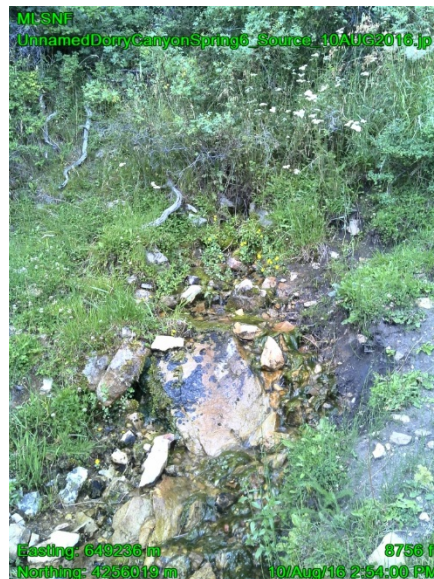
Photograph 11 (August 10, 2016) - Presumed spring source at Unnamed Dorry Canyon Spring #6. Photograph is georeferenced and indicated in the field map (Figure 1).

- Grazing impacts seemed to be minimal at this spring site, but ongoing monitoring should occur to determine if future work (e.g., exclosure) is needed.
- Non-native grasses were present at the site and should be a focus for managers into the future. We encourage managers to research and apply site-appropriate methods where possible.

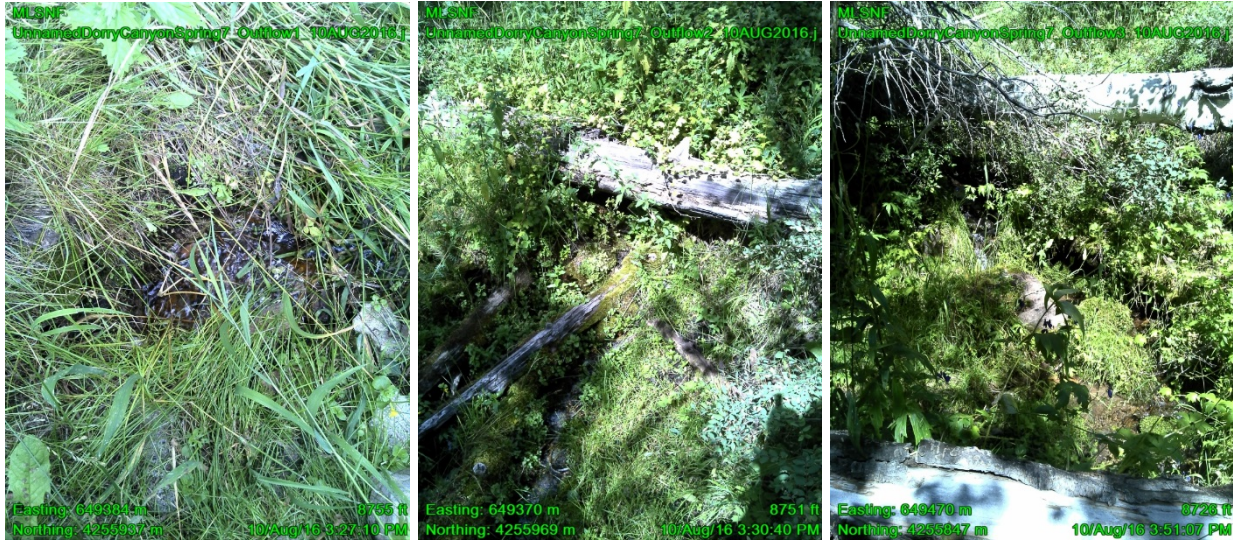
Photograph Set 12 (August 10, 2016) – Central (left), northern-most (middle), and southern-most (right) outflow points documented at Unnamed Dorry Canyon Spring #7.

- The utility of the pipeline should be identified and, if not in use, it should be removed.
- Non-native grasses were present at the site and should be a focus for managers into the future. We encourage managers to research and apply site-appropriate methods where possible.

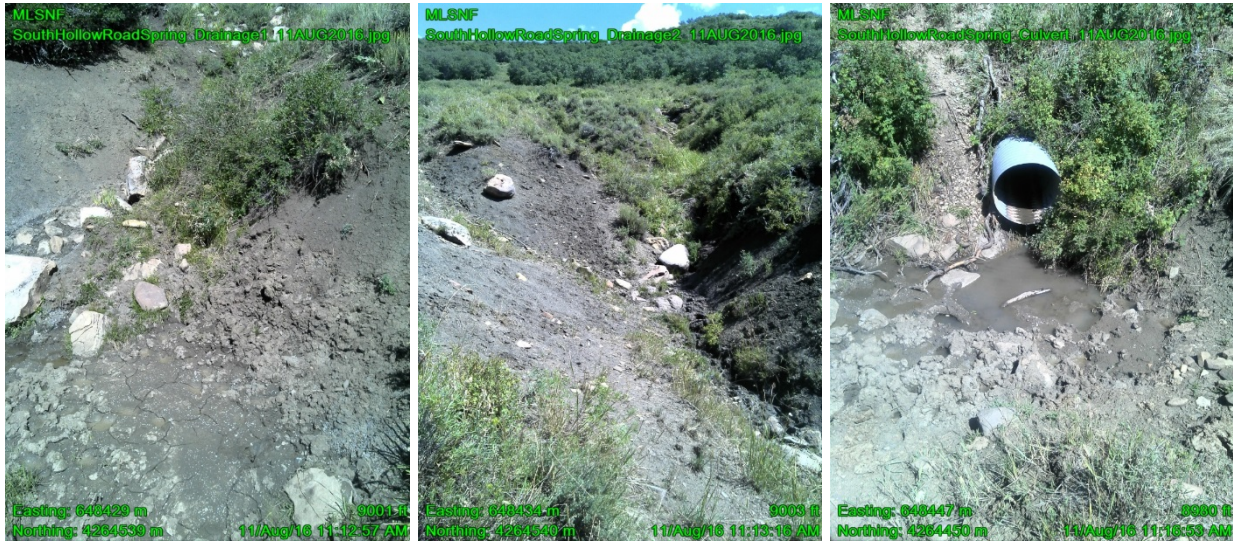
Water infrastructure: Culvert was present under road connecting upper drainage and lower drainage. A pipeline was present below enclosure, may have led to a downstream trough (although trough not located). Piece of pipeline was found at second outflow. No other infrastructure was found.

Fence infrastructure: Lower drainage had wooden railing enclosure which was in need of repair.

Photograph Set 13 – Upper (left) and lower (middle) drainage, connected by culvert at road (right) at South Hollow Road Spring. Photos are georeferenced and indicated in the field map (Fig. 1).

- This site was the focus of ongoing restoration. The existing exclosure of the downstream drainage should be repaired where needed and a similar exclosure for the upstream drainage should be considered given the extensive erosion and trampling here. To address the channeling and erosion in the drainages, resources such as the United States Forest Service's Guidance for Stream Restoration and Rehabilitation³ are available and include recommendations specific to incised channels.
- Non-native grasses are present at the site and should be a focus for managers into the future. We encourage managers to research and apply site-appropriate methods where possible.

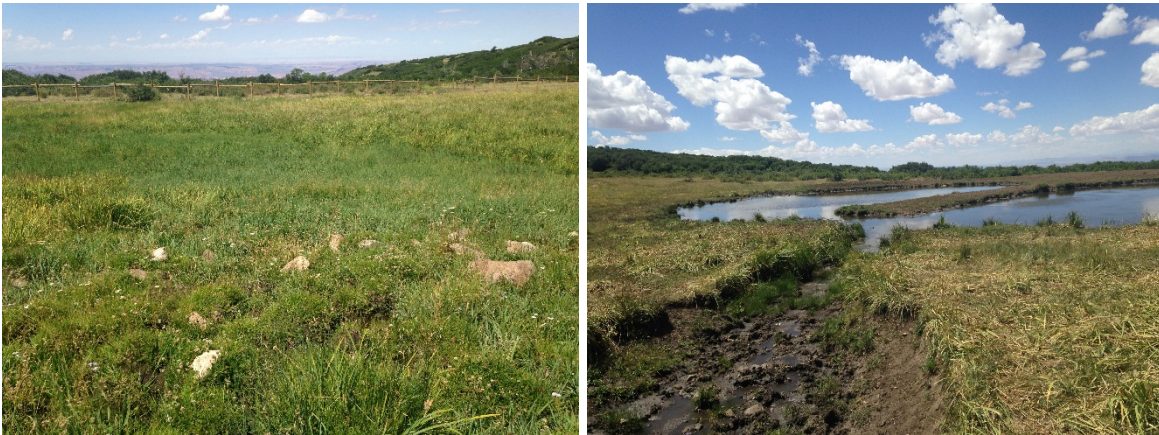
Photograph Set 14 (August 11, 2016) – Recently fenced wet meadow (left) and human-made cattle pond (right) at South Hollow Pond Spring. Substantial erosion and channeling were occurring at the lower part of the drainage where it meets the pond (right).

- While the wet meadow was well-protected from livestock trampling, the lower portion of the runoff channel/spring outflow was substantially incised, likely from trampling-induced erosion. We recommend following the guidance for incised channel restoration that is

present in the United States Forest Service's Guidance for Stream Restoration and Rehabilitation⁴.

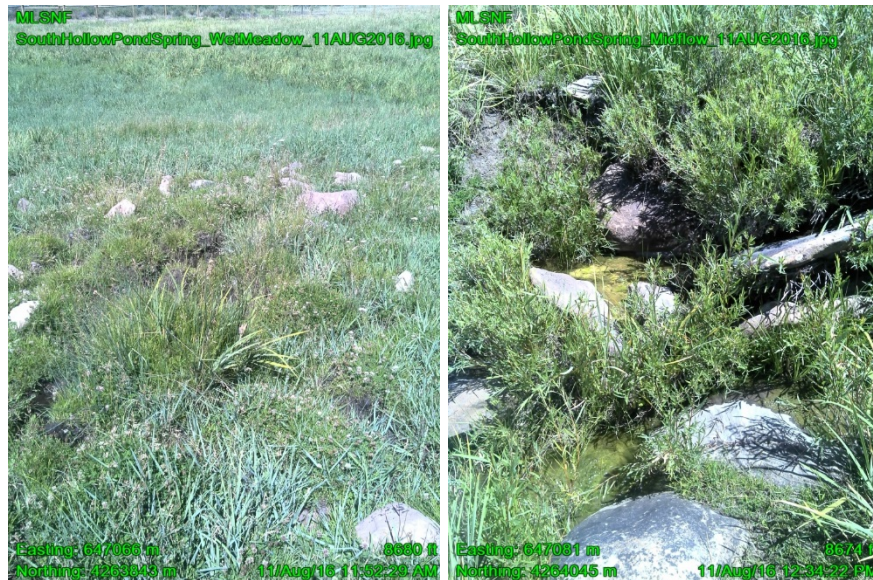
Photograph 15 (August 11, 2016) – Wettest portion of wet meadow (left) was likely a source at South Hollow Pond Spring. A side creek flowed down a drainage north of the wet meadow and had a diversity of riparian plants including willow (right). This drainage flowed into a human-made cattle pond. Source of spring was likely northwest of the right photograph further up the drainage; a United States topographic map from 2013 indicates a spring source approximately 3,280 feet up the drainage. Photographs are georeferenced and indicated in the field (Figure 1)
