EXCAVATIONS AT WEST BENCH PUEBLO

VERMILION CLIFFS NATIONAL MONUMENT

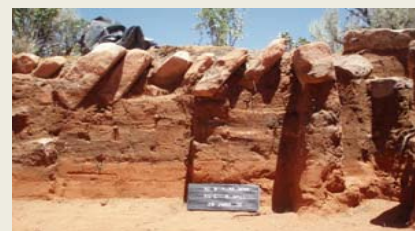
Excavation of XU-E in 2008 re-opened a vandalized area in the main roomblock to expose adjacent undisturbed deposits, revealing stratified deposits with wall fall sealing room fill (Strat I) above a clay-plastered floor (Strat II) that was built on top of charcoal-stained cultural fill (Strat III) overlying a largely-sterile substrate (Strat IV).

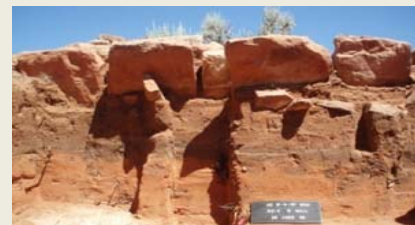
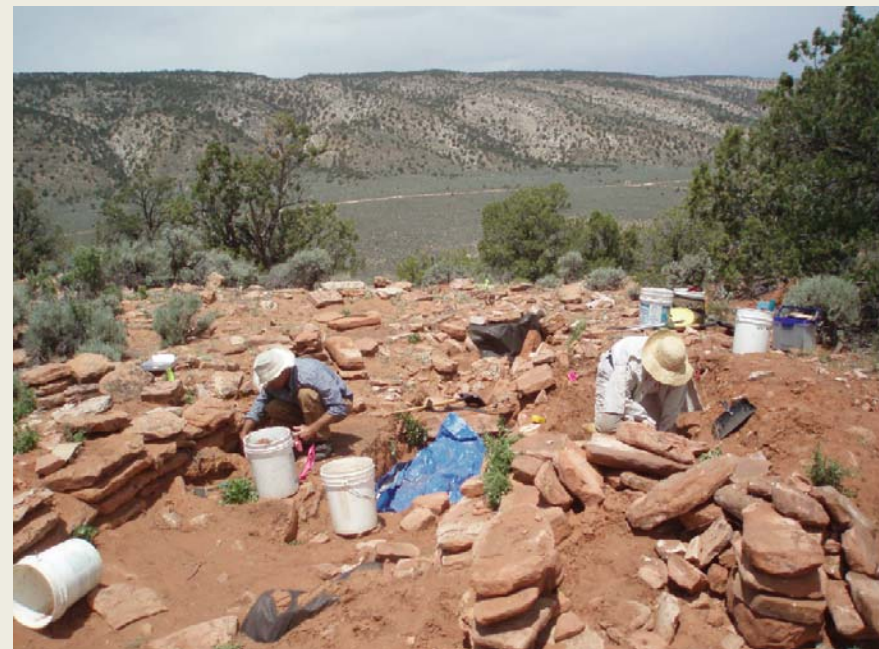
In 2008, XUs G and H were placed where the road formerly crossed the main roomblock. These units were intended to determine if there were intact deposits present within the roadway. Both were placed along the sides of the road in areas that appeared to contain wall fall.

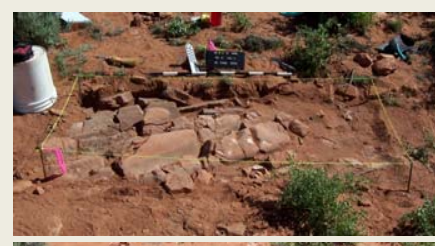
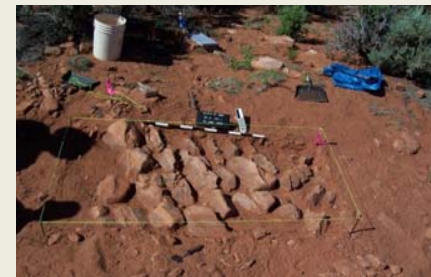
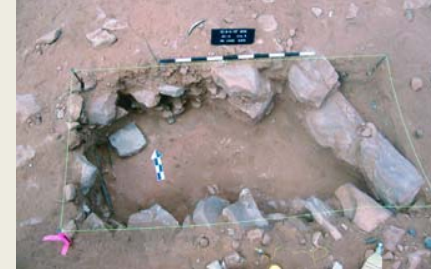
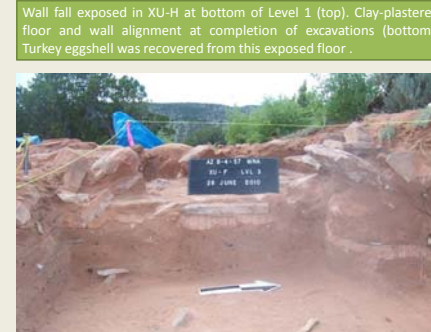
Wall fall exposed in XU-G after excavation of Level 1 (top), wall fall removed revealing largely intact clay-plastered and slab-lined floor (bottom). The eastern portion of the floor (to right in photo) had been damaged by vehicular traffic.

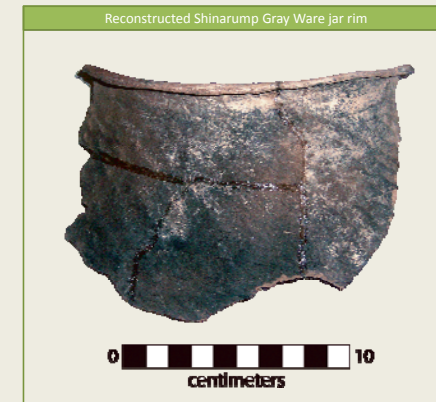
SERIATING GRAYWARES
Corrugated surface treatments were adopted after 1050, and became more common through time. As a result, the relative proportions of corrugated and plain sherds can be used to order ceramic assemblages in relation to one another.
