# SURVEY OF SELECTED SPRINGS OF BEARS EARS NATIONAL MONUMENT

***By: Marc Coles-Ritchie***

***Grand Canyon Trust***

***April 28, 2017***

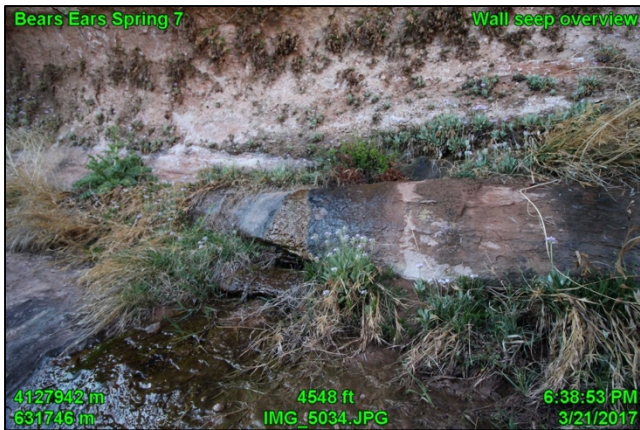
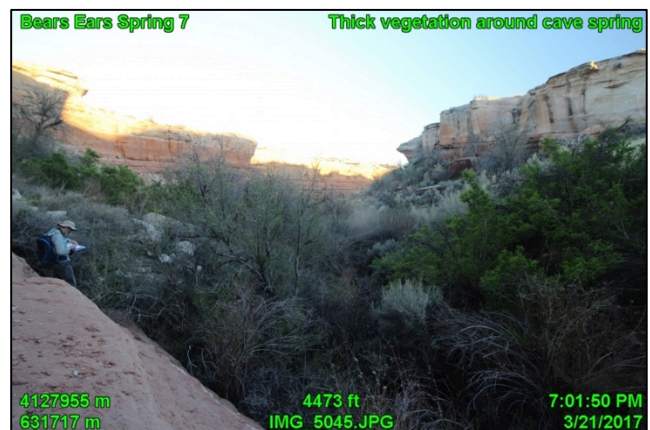
### Spring 7

<b>Spring 7</b>	
<b>Location</b>	On the east edge of town of Bluff, above St. Christopher's Episcopal Mission.
<b>UTM (at source)</b>	4127942 N, 631746 E.
<b>Hydrology</b>	There is a long, linear, wet wall with a small area of visible discharge. Below the wall, water comes out of a cave and flows as a stream.
<b>Common woody species</b>	Narrowleaf willow ( <i>Salix exigua</i> ).
<b>Other woody species</b>	Stretchberry ( <i>Forestiera pubescens</i> ), singleleaf ash ( <i>Fraxinus anomala</i> ).
<b>Common herbaceous species</b>	On wet wall: cavedwelling primrose ( <i>Primula specuicola</i> ), which is endemic to SE Utah (see photo); in broader spring area is common reed ( <i>Phragmites australis</i> ).

<i>Cavedwelling primrose</i>
<b>Noxious weeds</b>	Five-stamen tamarisk ( <i>Tamarix chinensis</i> ) and Russian olive ( <i>Eleagnus angustifolia</i> ).
<b>Vegetation association</b>	Mancos Columbine - Eastwood's Monkeyflower Hanging Garden; and Stretchberry Wet Shrubland.

<b>Wildlife</b>	Rodent droppings and tracks.
<b>Disturbance</b>	None observed.
<b>Condition</b>	High condition. Much vegetation and diversity of species. No evidence of erosion or other human impacts. Wet wall has endemic plants. This is an impressive spring and riparian area. There are some non-native plants. Private land is below the site, which may have prevented access by livestock or other disturbances.

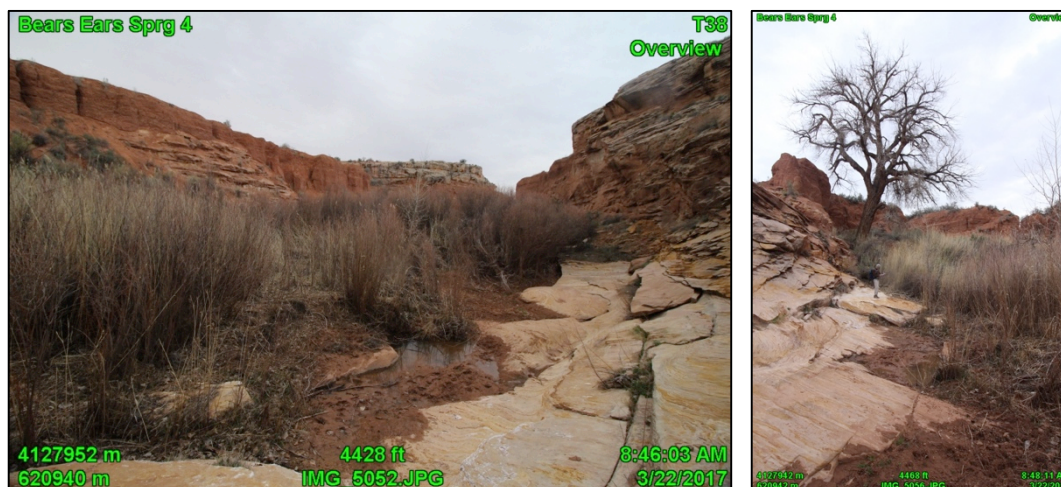
<b>Spring 4</b>	
<b>Location</b>	West of town of Bluff, near Comb Ridge.
<b>UTM (at source)</b>	4127952 N, 620940 E.
<b>Hydrology</b>	There is a pool and some flow in the stream. Water seems to be close to surface over a large area.
<b>Common woody species</b>	Narrowleaf willow ( <i>Salix exigua</i> ); a very large Fremont cottonwood ( <i>Populus fremontii</i> ) and a few small trees.
<b>Other woody species</b>	Five-stamen tamarisk ( <i>Tamarix chinensis</i> ).
<b>Common herbaceous species</b>	Common reed ( <i>Phragmites australis</i> ).
<b>Noxious weeds</b>	Five-stamen tamarisk ( <i>Tamarix chinensis</i> ).
<b>Wildlife</b>	Canid tracks, rodent scat, bird observed (maybe flycatcher) and nest.
<b>Vegetation association</b>	Narrowleaf Willow / Mesic Graminoids Western Wet Shrubland; and Common Reed Western Ruderal Wet Meadow.
<b>Disturbance</b>	Livestock.
<b>Condition</b>	Medium condition. This spring supports a lot of wetland vegetation. Apparently there is much water close to the surface. It is in a canyon that is somewhat difficult to access, which may protect it from overgrazing. Abundant riparian vegetation is present along the stream for miles, so that also may have reduced pressure from livestock on this site.

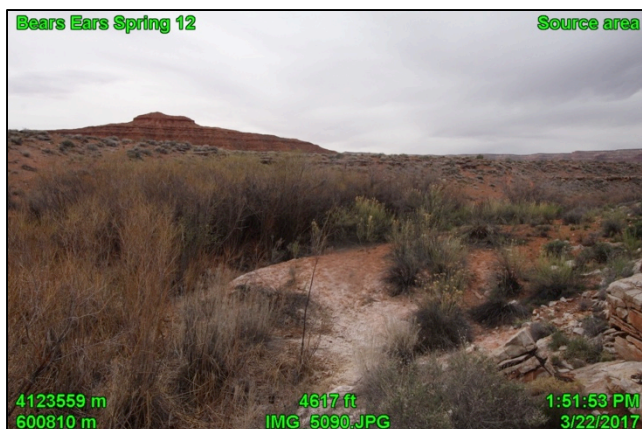
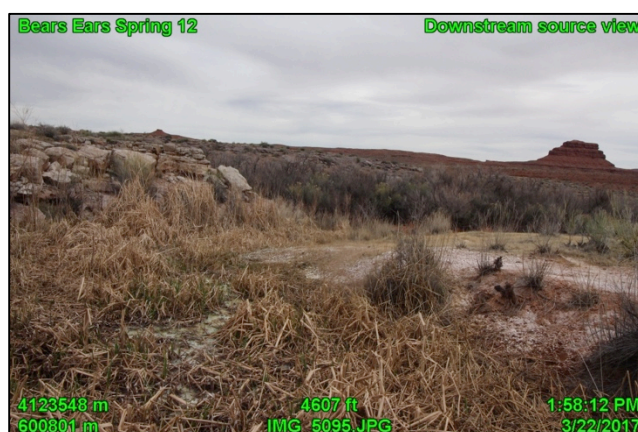
<b>Spring 12</b>	
<b>Location</b>	In Valley of the Gods.
<b>UTM (at source)</b>	4123559 N, 600810 E.
<b>Hydrology</b>	Standing water and wetland vegetation are present; and some flow in the channel.
<b>Common woody species</b>	Narrowleaf willow ( <i>Salix exigua</i> ).
<b>Other woody species</b>	Five-stamen tamarisk ( <i>Tamarix chinensis</i> ), singleleaf ash ( <i>Fraxinus anomala</i> ).
<b>Common herbaceous species</b>	Broadleaf cattail ( <i>Typha latifolia</i> ) and hardstem bulrush ( <i>Schoenoplectus acutus</i> ).
<b>Noxious weeds</b>	Five-stamen tamarisk ( <i>Tamarix chinensis</i> ).
<b>Vegetation association</b>	Narrowleaf Willow / Mesic Graminoids Western Wet Shrubland; and Broadleaf Cattail Marsh.
<b>Wildlife</b>	No signs observed.
<b>Disturbance</b>	Livestock; non-functioning, old trough.
<b>Condition</b>	Medium condition. The spring is in a channel setting, with significant water that supports a lot of wetland vegetation at this site and downstream. Livestock have removed much vegetation especially on the margins, but dense vegetation remains. A terrace above the channel is significantly disturbed by livestock, with salt crusts, much bare ground, and saltgrass. The site is degraded, but still a functional spring and wetland. Robust biocrusts (pinnacled with dark cyanobacteria, crustose and gelatinous lichens, and moss) are nearby.

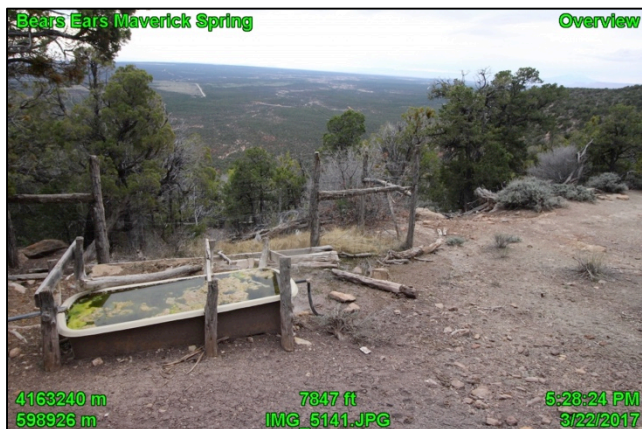
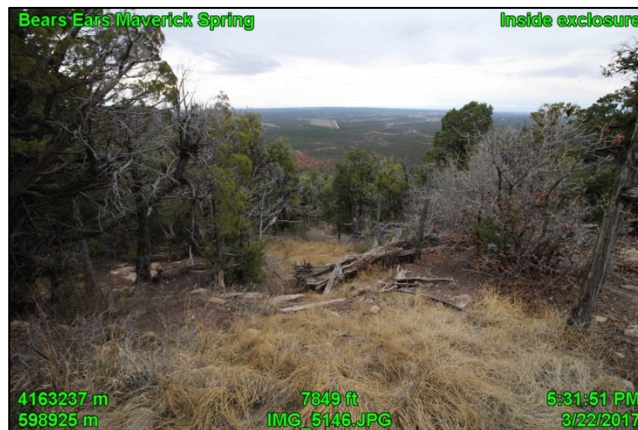
### Maverick Spring (Spring 136)

<b>Location</b>	Along road (Elk Mountain FR 0088) to Bears Ears buttes, above Natural Bridges National Monument.
<b>UTM (at source)</b>	4163242 N, 598931 E.
<b>Hydrology</b>	A pipe from the ground sends flow into the tank (looks like a bathtub) which overflows to a fenced wetland.
<b>Common woody species</b>	Wetland is mostly herbaceous vegetation.
<b>Other woody species</b>	Rubber rabbitbrush ( <i>Ericameria nauseosa</i> ), two-needle pinyon ( <i>Pinus edulis</i> ), Utah juniper ( <i>Juniperus osteosperma</i> ), Woods' rose ( <i>Rosa woodsii</i> ).
<b>Common herbaceous species</b>	Arctic (or Baltic) rush ( <i>Juncus arcticus</i> ).
<b>Noxious weeds</b>	None observed.
<b>Wildlife</b>	Bear scat; other scat.
<b>Vegetation association</b>	Baltic Rush Wet Meadow.
<b>Disturbance</b>	Livestock.
<b>Condition</b>	Medium condition. This spring is developed to provide water to livestock. A pipe feeds a tank that overflows and supports a rush wetland that is fenced. Outside the fence the vegetation is heavily grazed, with much bare ground. Rose and rabbitbrush are heavily browsed outside the fence. The fenced area is in good condition.

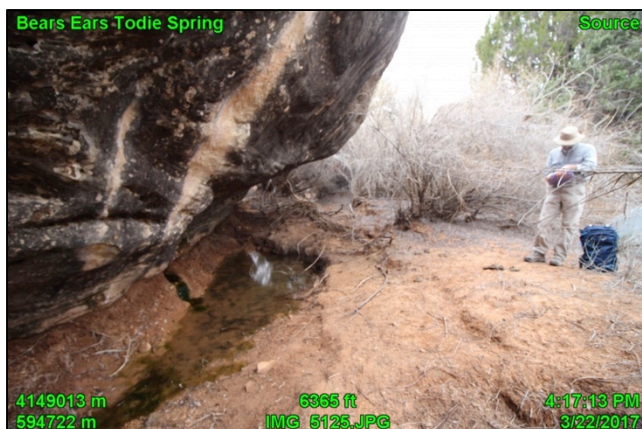
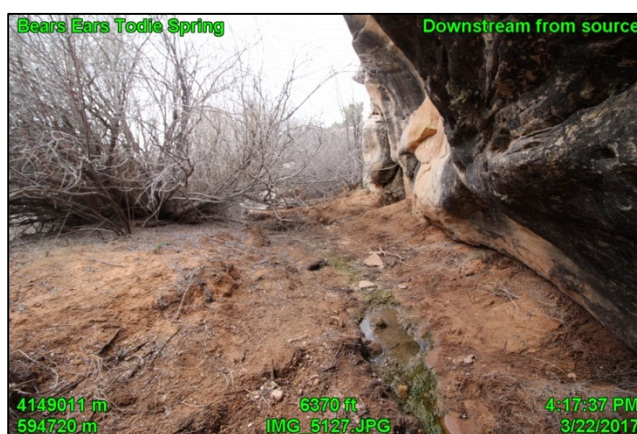
<b>Todie Spring</b>	
<b>Location</b>	Cedar Mesa, off Highway 261, near Todie Spring Trailhead.
<b>UTM (at source)</b>	4149013 N, 594722 E.
<b>Hydrology</b>	A small pool of still water of about 15 square ft is present. There is no visible flow.
<b>Common woody species</b>	Narrowleaf willow ( <i>Salix exigua</i> ) and arroyo willow ( <i>Salix lasiolepis</i> ).
<b>Other woody species</b>	Five-stamen tamarisk ( <i>Tamarix chinensis</i> ).
<b>Common herbaceous species</b>	Almost no herbaceous vegetation.
<b>Noxious weeds</b>	Five-stamen tamarisk ( <i>Tamarix chinensis</i> ).
<b>Vegetation association</b>	Arroyo Willow / Barren Ground Wet Shrubland.
<b>Wildlife</b>	Pellet scat; and birds observed.
<b>Disturbance</b>	Livestock and broken, old water tank.
<b>Condition</b>	Medium condition. Livestock seem to have removed much of the herbaceous vegetation and caused erosion. A rock face to the north is about 15' tall; water seeps from there. Willows dominate the site but there is significant bare ground. Robust biocrusts (pinnacled with dark cyanobacteria, crustose and gelatinous lichens, and moss) are nearby -- between trailhead parking area and the spring.

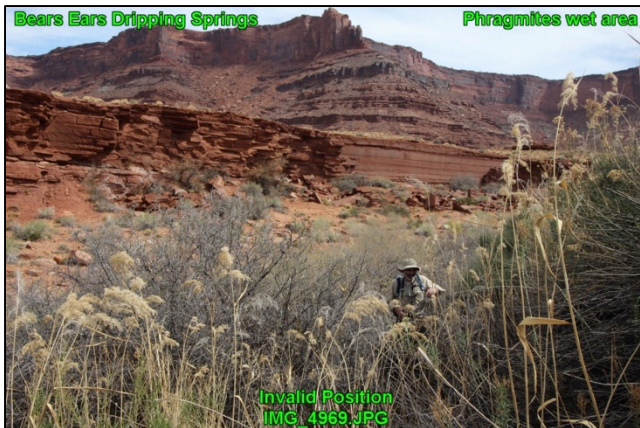
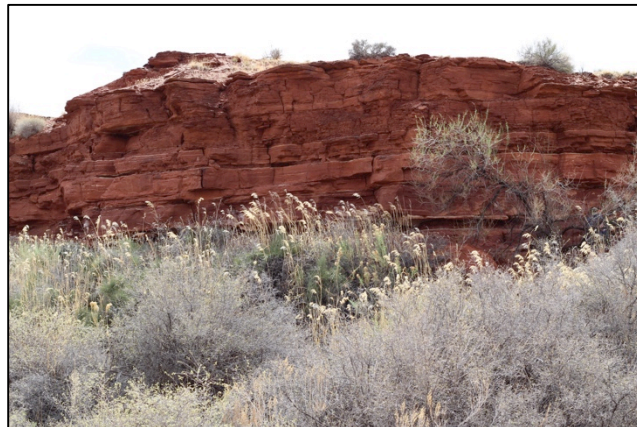
<b>Dripping Springs Wetland</b>	
<b>Location</b>	East of Colorado River, South of Hurrah Pass. This is toward the lower end of the Dripping Springs complex.
<b>UTM (at source)</b>	4255694 N, 618176 E.
<b>Hydrology</b>	No surface water is visible, but common reed indicates water is in the soil. The spring is not part of the stream channel where Dripping Springs flows, but it contributes to the Dripping Springs stream.
<b>Common woody species</b>	Five-stamen tamarisk ( <i>Tamarix chinensis</i> ).
<b>Other woody species</b>	Fragrant sumac ( <i>Rhus aromatica</i> ).
<b>Common herbaceous species</b>	Common reed ( <i>Phragmites australis</i> ).
<b>Noxious weeds</b>	Five-stamen tamarisk ( <i>Tamarix chinensis</i> ).
<b>Vegetation association</b>	Common Reed Western Ruderal Wet Meadow.
<b>Wildlife</b>	None observed.
<b>Disturbance</b>	None obvious.
<b>Condition</b>	Medium condition. This hillslope wetland has abundant vegetation, but no surface water is visible.

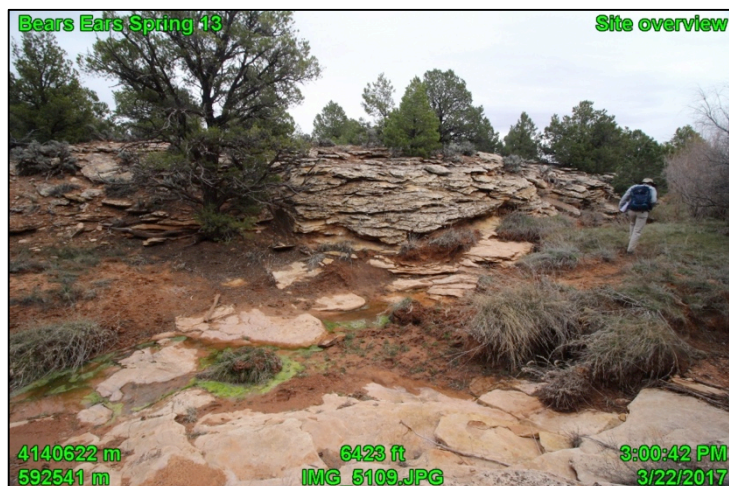
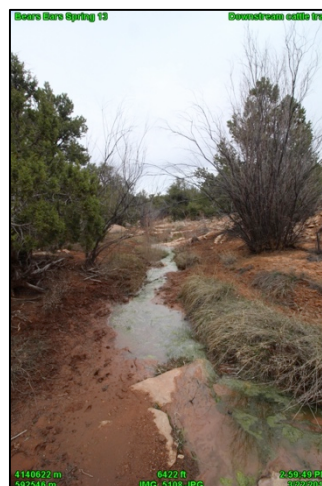
### Spring 13

<b>Spring 13</b>	
<b>Location</b>	Cedar Mesa, off Cigarette Springs Road.
<b>UTM (at source)</b>	4140624 N, 592547 E.
<b>Hydrology</b>	Small pools of still water are visible, but no visible flow.
<b>Common woody species</b>	Narrowleaf willow ( <i>Salix exigua</i> ).
<b>Other woody species</b>	Five-stamen tamarisk ( <i>Tamarix chinensis</i> ).
<b>Common herbaceous species</b>	Arctic rush ( <i>Juncus arcticus</i> ).
<b>Noxious weeds</b>	Five-stamen tamarisk ( <i>Tamarix chinensis</i> ).
<b>Vegetation association</b>	Narrowleaf Willow / Mesic Graminoids Western Wet Shrubland; and Tamarisk species Ruderal Riparian Shrubland.
<b>Wildlife</b>	Ungulate (deer or pronghorn), rodent, and canine tracks.
<b>Disturbance</b>	Livestock.
<b>Condition</b>	Low condition. This spring has standing water and some wetland vegetation. There is significant erosion and downcutting (especially in the upper part), much bare ground and trampling. Non-native vegetation is abundant, in addition to some native vegetation. Robust biocrusts (pinnacled with dark cyanobacteria, crustose and gelatinous lichens, and moss) are nearby.

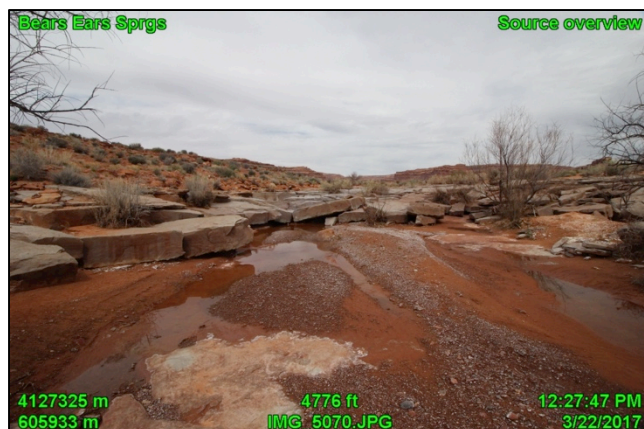
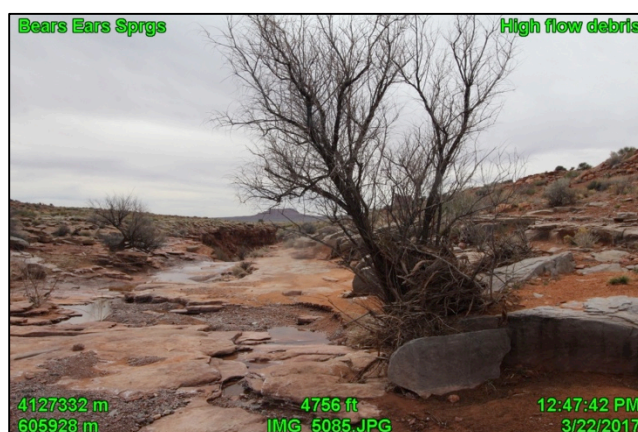
<b>Spring 11</b>	
<b>Location</b>	Near Valley of the Gods.
<b>UTM (at source)</b>	4127337 N, 605929 E.
<b>Hydrology</b>	There are numerous small pools, with a little flow between pools. Downstream the stream drips over rock ledge (15' drop) into a large pool.
<b>Common woody species</b>	Five-stamen tamarisk ( <i>Tamarix chinensis</i> ).
<b>Other woody species</b>	Fragrant sumac ( <i>Rhus aromatica</i> ), singleleaf ash ( <i>Fraxinus anomala</i> ).
<b>Common herbaceous species</b>	Arctic rush ( <i>Juncus arcticus</i> ), swordleaf rush ( <i>Juncus ensifolius</i> ).
<b>Noxious weeds</b>	Five-stamen tamarisk ( <i>Tamarix chinensis</i> ).
<b>Wildlife</b>	Rodent or rabbit scat/pellets; canid tracks and scat; aquatic organisms observed in water (water bug, caddisfly, water shrimp, eggs, mayfly, tadpole, snail).
<b>Vegetation association</b>	Tamarisk species Ruderal Riparian Shrubland.
<b>Disturbance</b>	Livestock.

<b>Condition</b>	Low condition. This spring discharges into the stream channel. There are ungulate impacts (likely livestock) such as grazing of vegetation and bank disturbance. There are small patches of rushes. This is a surprising little wet oasis in the desert. There is not a lot of vegetation, and much bare ground, probably because of ungulate grazing. There are some native, wetland plant species, and numerous aquatic organisms.

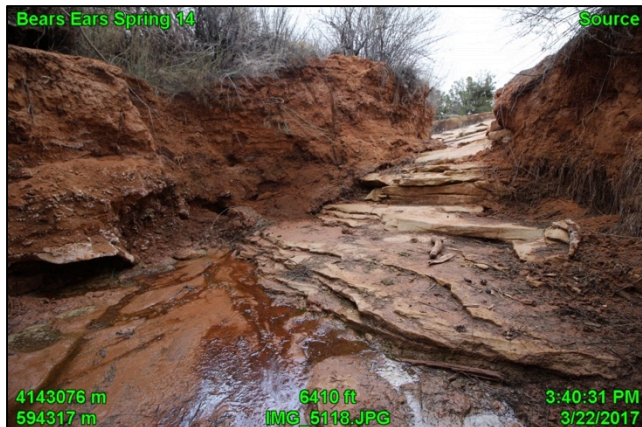
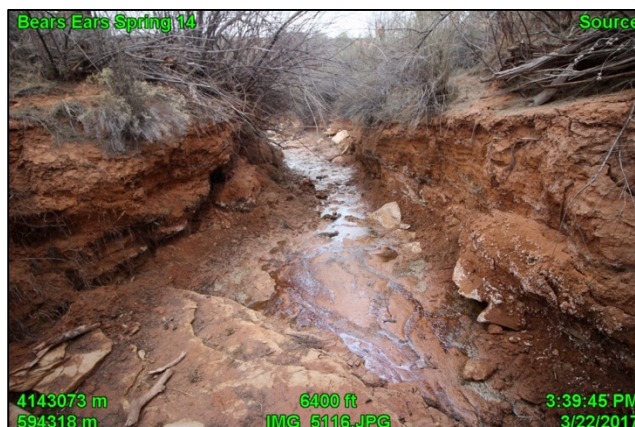
### Spring 14

<b>Spring 14</b>	
<b>Location</b>	On Cedar Mesa, along highway 261, above a culvert.
<b>UTM (at source)</b>	4143073 N, 594318 E.
<b>Hydrology</b>	Water is in small pools in the channel with a bit of flow.
<b>Common woody species</b>	Five-stamen tamarisk ( <i>Tamarix chinensis</i> ).
<b>Other woody species</b>	Minimal woody vegetation.
<b>Common herbaceous species</b>	Arctic rush ( <i>Juncus arcticus</i> ).
<b>Noxious weeds</b>	Five-stamen tamarisk ( <i>Tamarix chinensis</i> ).
<b>Wildlife</b>	Birds (multiple species) observed; canid track; rodent track; wild horse scat.
<b>Vegetation association</b>	Tamarisk species Ruderal Riparian Shrubland.
<b>Disturbance</b>	Livestock.
<b>Condition</b>	Low condition. Spring site has significant erosion and downcutting, probably due to livestock. There is not much cover of riparian vegetation. The site is mostly bare, eroded soil. It seems that water seeps out between rock layers along this stream for a few hundred feet at least, above and below a culvert under Highway 261. There are multiple headcuts (erosion drops) both above and below the culvert.

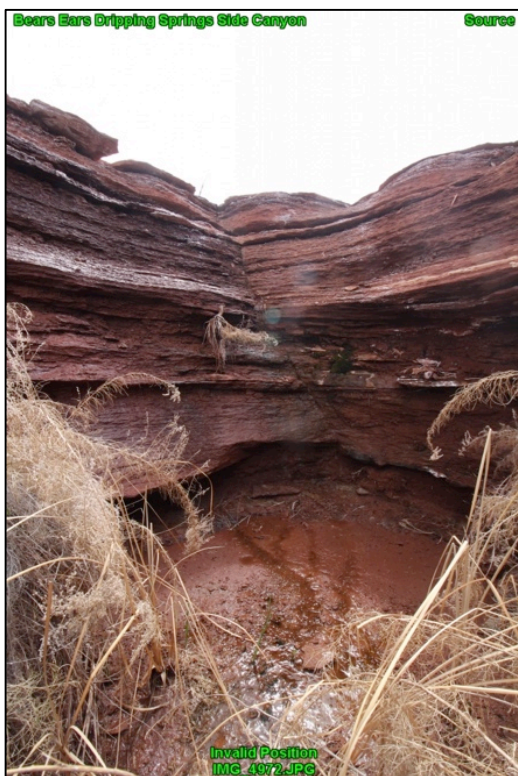
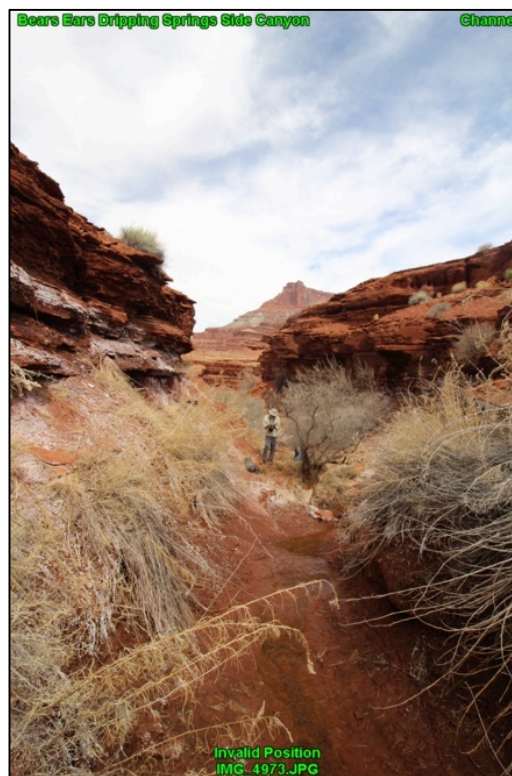
### Side Canyon of Dripping Springs Stream

<b>Location</b>	South of Hurrah Pass. This is a side canyon of the Dripping Springs complex.
<b>UTM (at source)</b>	4255626 N, 618167 E.
<b>Hydrology</b>	A small but steady flow for about 80 ft.
<b>Common woody species</b>	Five-stamen tamarisk ( <i>Tamarix chinensis</i> ).
<b>Other woody species</b>	Fragrant sumac ( <i>Rhus aromatica</i> ).
<b>Common herbaceous species</b>	Saltgrass ( <i>Distichlis spicata</i> ).
<b>Noxious weeds</b>	Five-stamen tamarisk ( <i>Tamarix chinensis</i> ).
<b>Vegetation association</b>	Tamarisk species Ruderal Riparian Shrubland.
<b>Wildlife</b>	None observed.
<b>Disturbance</b>	Livestock.
<b>Condition</b>	Low condition. This spring is tucked away, up a narrow side canyon, with a small cliff/water drop at the upper end, so it is a bit more protected than the main part of the Dripping Springs complex. There is still much bare ground.

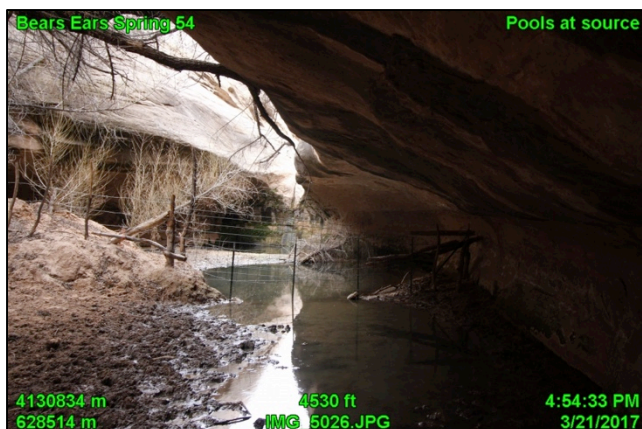
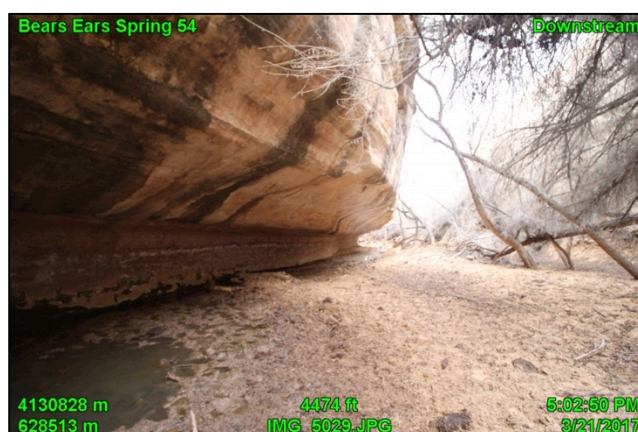
<b>Spring 54</b>	
<b>Location</b>	Just north of Bluff, off powerline road.
<b>UTM (at source)</b>	4130834 m, 628514 m
<b>Hydrology</b>	Some large pools total about a few hundred square ft, with stagnant water. A small amount of flow from the wet wall feeds the pool at the base.
<b>Common woody species</b>	Goodding's willow ( <i>Salix gooddingii</i> ).
<b>Other woody species</b>	None.
<b>Common herbaceous species</b>	None evident.
<b>Noxious weeds</b>	None observed.
<b>Vegetation association</b>	Goodding's Willow / Narrowleaf Willow Riparian Woodland.
<b>Wildlife</b>	None observed.
<b>Disturbance</b>	There is a fence around the spring source. Livestock are a significant impact.
<b>Condition</b>	Low condition. The site is in a narrow canyon with vertical walls so the only access is from the downstream end. The spring is a wet wall, forming a pool at the base. Surprisingly there is no herbaceous vegetation; cows apparently have eaten it all. It is mostly bare ground and old willow trees, which are breaking and falling. Cow dung is abundant. A fence blocks access to the spring source (wet wall) and most of the pool, but some cow dung is inside the fence. The wet wall has some hanging garden vegetation, but it was not possible to get close enough to identify it, due to the fence and pool.

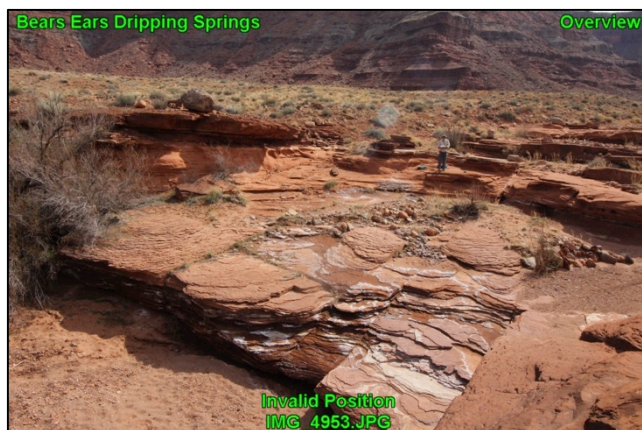
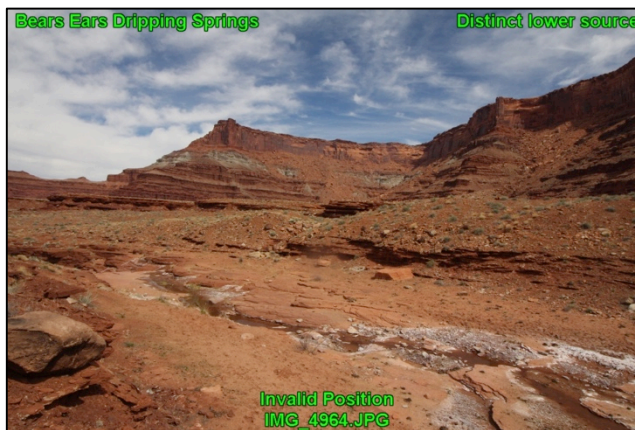
<b>Dripping Springs</b>	
<b>Location</b>	East of Colorado River, South of Hurrah Pass. This is the upper-most point of the Dripping Springs complex.
<b>UTM (at source)</b>	4255325 N, 618535 E.
<b>Hydrology</b>	Water drips from rock layers at various points and accumulates in the channel. There is much salt encrusted soil and rock. Both small (3 square ft) and larger (20 square ft) pools are present, and there is some flow between pools in the stream channel.
<b>Common woody species</b>	Five-stamen tamarisk ( <i>Tamarix chinensis</i> ).
<b>Other woody species</b>	Fragrant sumac ( <i>Rhus aromatica</i> ), narrowleaf willow ( <i>Salix exigua</i> ).
<b>Common herbaceous species</b>	Saltgrass ( <i>Distichlis spicata</i> ).
<b>Noxious weeds</b>	Five-stamen tamarisk ( <i>Tamarix chinensis</i> ).
<b>Vegetation association</b>	Tamarisk species Ruderal Riparian Shrubland.
<b>Wildlife</b>	Hawk flying, deer tracks.

<b>Disturbance</b>	Livestock and native ungulates.
<b>Condition</b>	Low condition. There is little vegetation at this spring and riparian area, with a lot of bare ground and a significant amount of invasive species. This site appears to be heavily impacted by livestock based on tracks, trails, browse and scat.

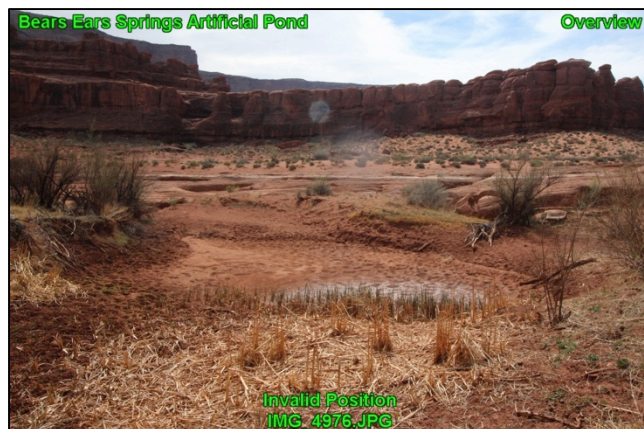
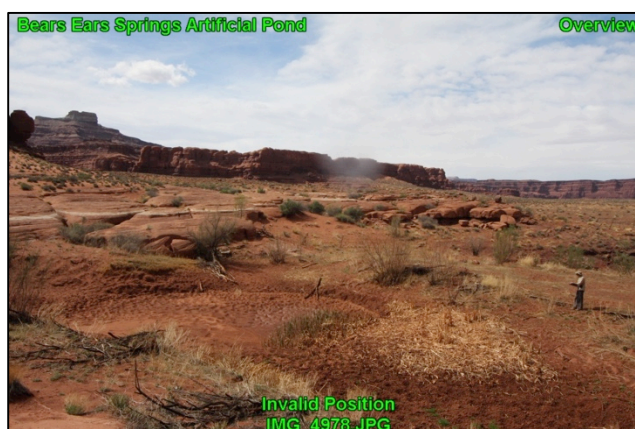
### Spring 1

<b>Spring 1</b>	
<b>Location</b>	East of Colorado River, South of Hurrah Pass and south of the Dripping Springs stream, along a well-traveled road.
<b>UTM (at source)</b>	4254264 N, 614587 E.
<b>Hydrology</b>	This appears to be a pond dug out behind an earthen dam created as a livestock water source. No surface water is visible, but abundant wetland vegetation indicates soil moisture.
<b>Common woody species</b>	Five-stamen tamarisk ( <i>Tamarix chinensis</i> ).
<b>Other woody species</b>	Greasewood ( <i>Sarcobatus vermiculatus</i> ).
<b>Common herbaceous species</b>	Broadleaf cattail ( <i>Typha latifolia</i> )
<b>Noxious weeds</b>	Five-stamen tamarisk ( <i>Tamarix chinensis</i> ).
<b>Vegetation association</b>	Tamarisk species Ruderal Riparian Shrubland.
<b>Wildlife</b>	None observed.
<b>Disturbance</b>	Berm, dug from pond; vehicles, livestock.
<b>Condition</b>	Low condition. This site is heavily impacted by the creation of an artificial pond and use by livestock. Water is seeping down past the pond berm, creating moist soil below. This site is adjacent to a dirt road with parking area and garbage can. Bare ground predominates.

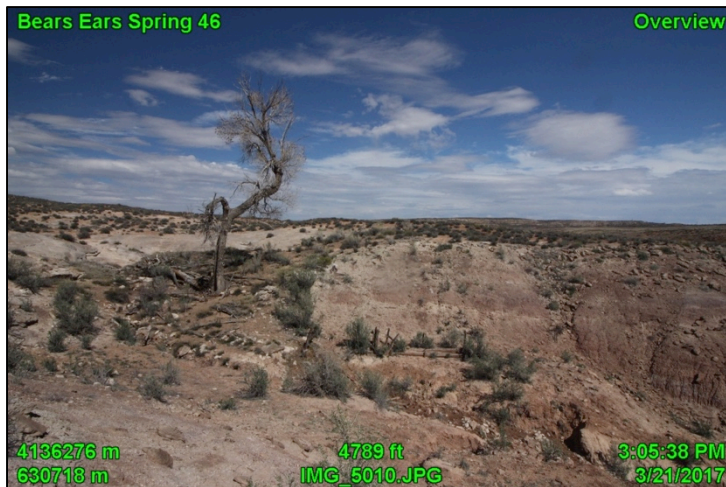
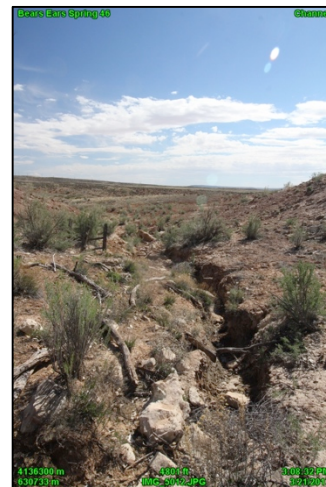
<b>Spring 46</b>	
<b>Location</b>	North of Bluff and west of Hwy 191.
<b>UTM (at source)</b>	4136290 N, 630731 E.
<b>Hydrology</b>	Water trickles from a pipe and flows down a degraded channel.
<b>Common woody species</b>	Greasewood ( <i>Sarcobatus vermiculatus</i> ).
<b>Other woody species</b>	Fragrant sumac ( <i>Rhus aromatica</i> ), rubber rabbitbrush ( <i>Ericameria nauseosa</i> ).
<b>Common herbaceous species</b>	Minimal herbaceous vegetation.
<b>Noxious weeds</b>	None observed.
<b>Vegetation association</b>	Greasewood / Rubber Rabbitbrush Wet Shrubland.
<b>Wildlife</b>	None observed.
<b>Disturbance</b>	Livestock, pipe, old trough (log).
<b>Condition</b>	Very low condition. This is a highly degraded hillslope spring. There is erosion and downcutting of ~3' in depth in some places. A lone cottonwood is not healthy or vigorous. Bare ground predominates.

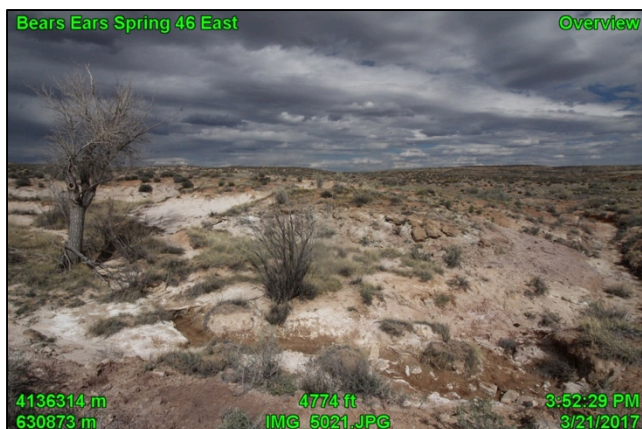
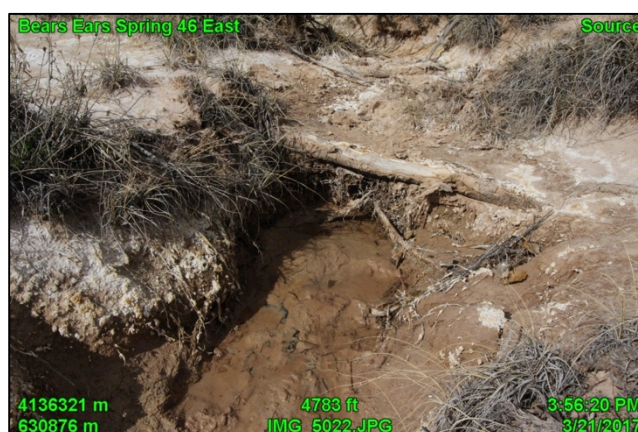
<b>Spring 46 East</b>	
<b>Location</b>	North of Bluff and west of Hwy 191.
<b>UTM (at source)</b>	4136321 N, 630876 E.
<b>Hydrology</b>	Tiny puddles of water are present, but no visible flow.
<b>Common woody species</b>	Five-stamen tamarisk ( <i>Tamarix chinensis</i> ).
<b>Other woody species</b>	Rubber rabbitbrush ( <i>Ericameria nauseosa</i> ).
<b>Common herbaceous species</b>	Alkali sacaton ( <i>Sporobolus airoides</i> ).
<b>Noxious weeds</b>	Five-stamen tamarisk ( <i>Tamarix chinensis</i> ).
<b>Vegetation association</b>	Tamarisk species Ruderal Riparian Shrubland.
<b>Wildlife</b>	Canid tracks, deer observed.
<b>Disturbance</b>	Livestock.
<b>Condition</b>	Very low condition. This is a highly impacted hillslope spring with minimal vegetation. There are patches of grass and one dying cottonwood. Bare ground and erosion are extensive.

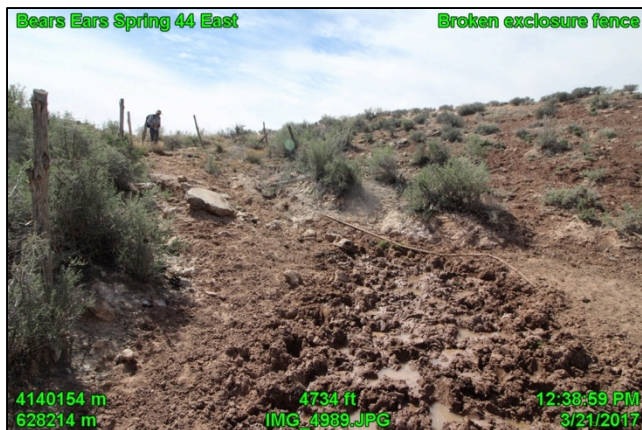
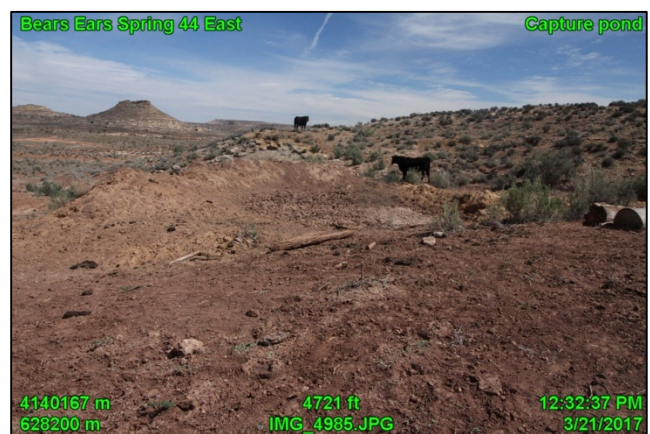
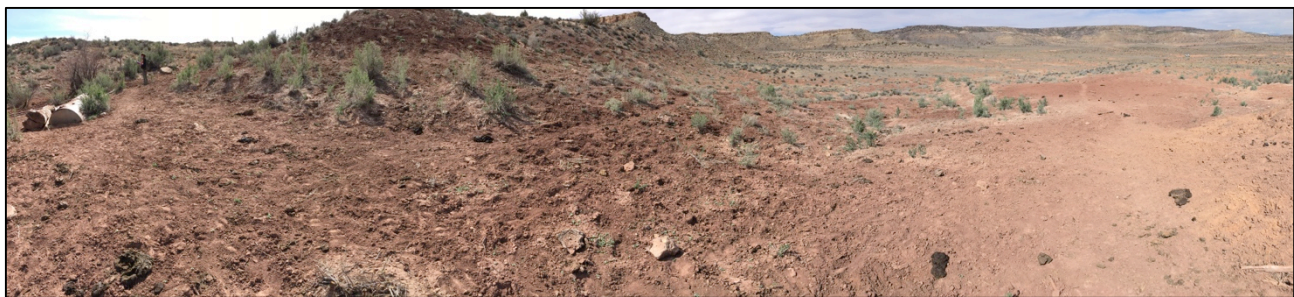
### Spring 44 East

<b>Location</b>	North of Bluff and west of Hwy 191.
<b>Coordinates (if not on photo)</b>	4140156 N, 628212 E.
<b>Hydrology</b>	Puddles of water are in hoof prints in the mud.
<b>Common woody species</b>	Greasewood ( <i>Sarcobatus vermiculatus</i> ).
<b>Other woody species</b>	Five-stamen tamarisk ( <i>Tamarix chinensis</i> ).
<b>Common herbaceous species</b>	Minimal herbaceous vegetation.
<b>Noxious weeds</b>	Five-stamen tamarisk ( <i>Tamarix chinensis</i> ).
<b>Vegetation association</b>	Greasewood / Rubber Rabbitbrush Wet Shrubland.
<b>Wildlife</b>	None observed.
<b>Disturbance</b>	Livestock trampling and grazing (cows observed at site); earthen dam and dry pond; a barbed wire fence is down; old pipes.
<b>Condition</b>	Very low condition. This hillslope spring is highly disturbed. It is mostly bare ground, and eroding soil. An earthen dam has been constructed to create a pond, but the pond site is dried, mud-cakes of hoof prints. This is a heavily degraded site.

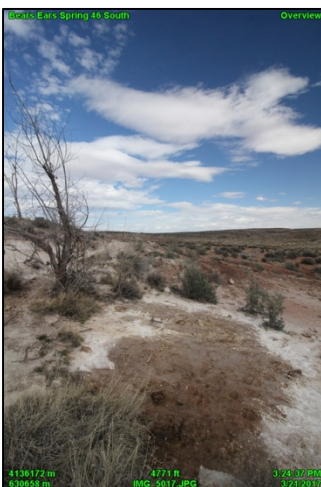
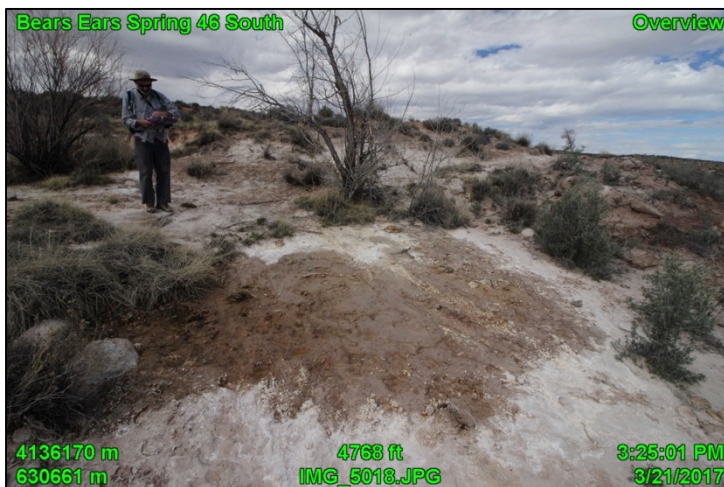
<b>Spring 46 South</b>	
<b>Location</b>	North of Bluff and west of Hwy 191.
<b>UTM (at source)</b>	4136172 N, 630658 E.
<b>Hydrology</b>	The soil is wet, with small puddles in hoof prints.
<b>Common woody species</b>	Greasewood ( <i>Sarcobatus vermiculatus</i> ).
<b>Other woody species</b>	Five-stamen tamarisk ( <i>Tamarix chinensis</i> ).
<b>Common herbaceous species</b>	Alkali sacaton ( <i>Sporobolus airoides</i> ).
<b>Noxious weeds</b>	Five-stamen tamarisk ( <i>Tamarix chinensis</i> ).
<b>Vegetation association</b>	Greasewood / Rubber Rabbitbrush Wet Shrubland.
<b>Wildlife</b>	None observed.
<b>Disturbance</b>	Livestock.
<b>Condition</b>	Very low condition. This is a highly degraded hillslope spring with minimal vegetation. The site is close to a dirt road. Cow trails and bare ground are common. A lone cottonwood is not vigorous. There are many salt crusts. Even the tamarisk is struggling to stay alive here.

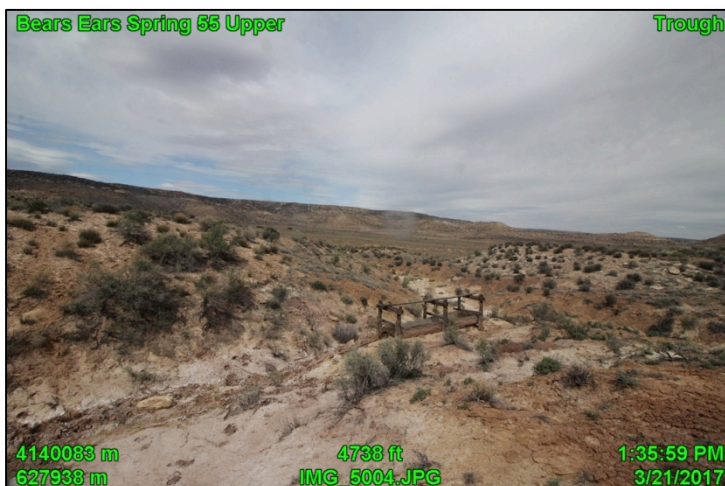
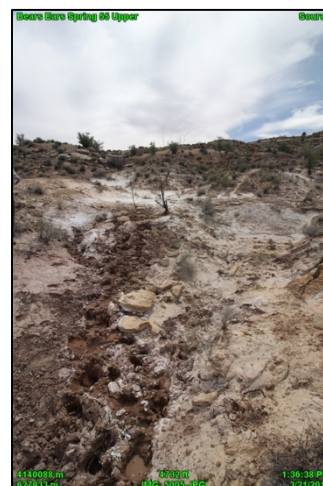
<b>Spring 55 Upper</b>	
<b>Location</b>	North of Bluff and west of Hwy 191.
<b>UTM (at source)</b>	4140088 N, 627933 E.
<b>Hydrology</b>	The soil is wet, with small puddles in hoof prints.
<b>Common woody species</b>	Greasewood ( <i>Sarcobatus vermiculatus</i> ).
<b>Other woody species</b>	Five-stamen tamarisk ( <i>Tamarix chinensis</i> ).
<b>Common herbaceous species</b>	Minimal herbaceous vegetation.
<b>Noxious weeds</b>	Five-stamen tamarisk ( <i>Tamarix chinensis</i> ).
<b>Vegetation association</b>	Greasewood / Rubber Rabbitbrush Wet Shrubland.
<b>Wildlife</b>	None observed.
<b>Disturbance</b>	Livestock; an old log trough and piping are not functional.
<b>Condition</b>	Very low condition. This is a highly degraded spring and stream channel. Almost no live vegetation is present along the stream. The site is heavily trampled, with bare ground predominating.

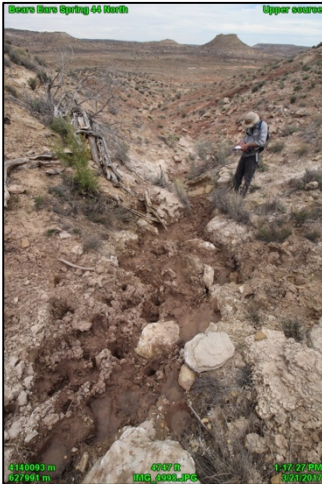
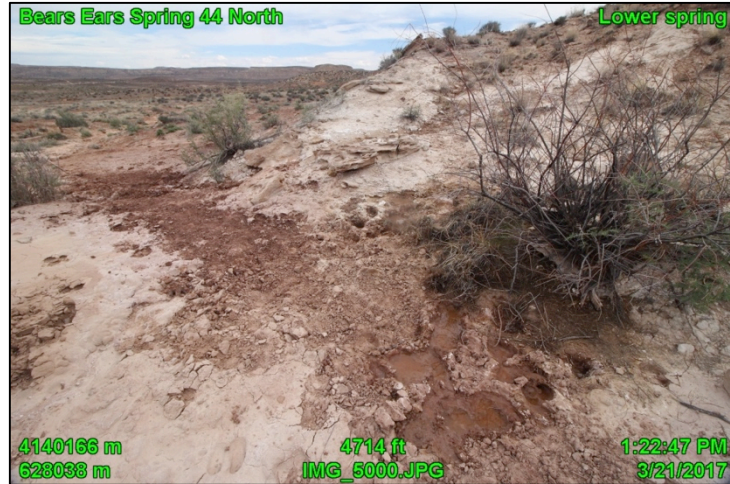
<b>Spring 44 North</b>	
<b>Location</b>	North of Bluff and west of Hwy 191.
<b>UTM (at source)</b>	4140095 N, 627987 E.
<b>Hydrology</b>	Muddy puddles of water are in hoof prints. About 200' downstream additional puddles of water are present.
<b>Common woody species</b>	Greasewood ( <i>Sarcobatus vermiculatus</i> ).
<b>Other woody species</b>	Rubber rabbitbrush ( <i>Ericameria nauseosa</i> ), Utah serviceberry ( <i>Amelanchier utahensis</i> ).
<b>Common herbaceous species</b>	Minimal herbaceous vegetation.
<b>Noxious weeds</b>	Five-stamen tamarisk ( <i>Tamarix chinensis</i> ).
<b>Vegetation association</b>	Greasewood / Rubber Rabbitbrush Wet Shrubland.
<b>Wildlife</b>	None observed.
<b>Disturbance</b>	Livestock.
<b>Condition</b>	Very low condition. This is a highly degraded hillslope spring with minimal riparian vegetation. It is heavily trampled and there is much bare ground. There are a few cottonwoods but they are dead or dying.

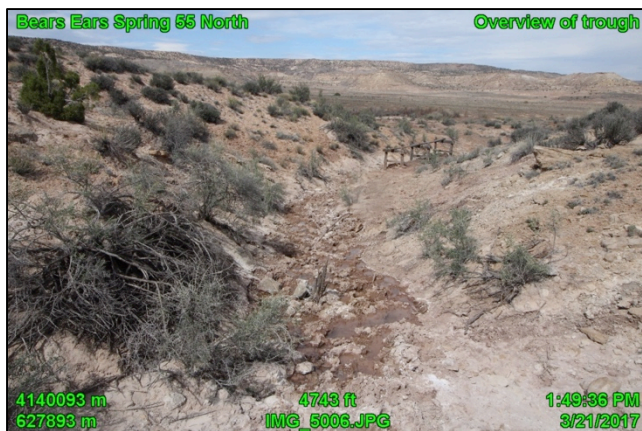
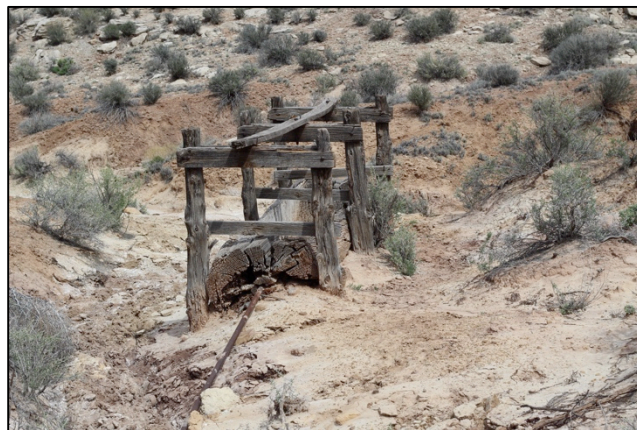
<b>Spring 55 North</b>	
<b>Location</b>	North of Bluff and west of Hwy 191.
<b>UTM (at source)</b>	4140093 N, 627893 E.
<b>Hydrology</b>	There are salt crusts and small puddles in the mud.
<b>Common woody species</b>	Greasewood ( <i>Sarcobatus vermiculatus</i> ).
<b>Other woody species</b>	None observed.
<b>Common herbaceous species</b>	Minimal herbaceous vegetation.
<b>Noxious weeds</b>	None observed.
<b>Vegetation association</b>	Greasewood / Rubber Rabbitbrush Wet Shrubland.
<b>Wildlife</b>	None observed.
<b>Disturbance</b>	Livestock, trough (old log), pipes.
<b>Condition</b>	Very low condition. This is a highly degraded spring that is part of stream channel. Hardly any vegetation remains, and the soil is heavily trampled and eroded.

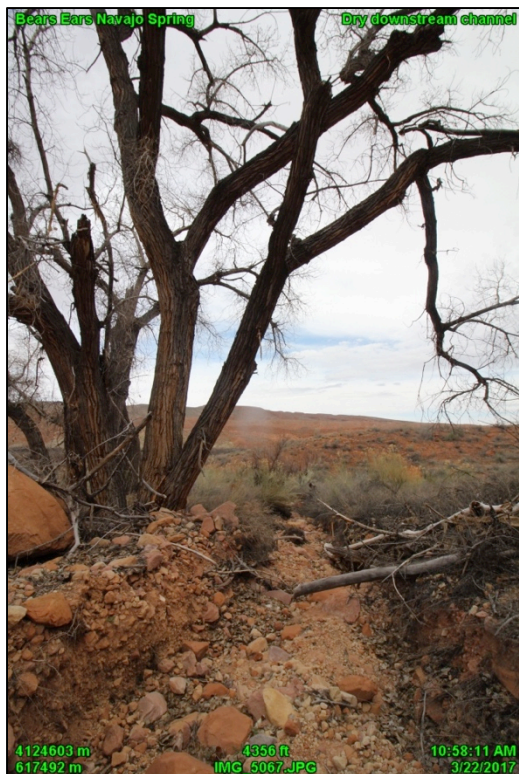
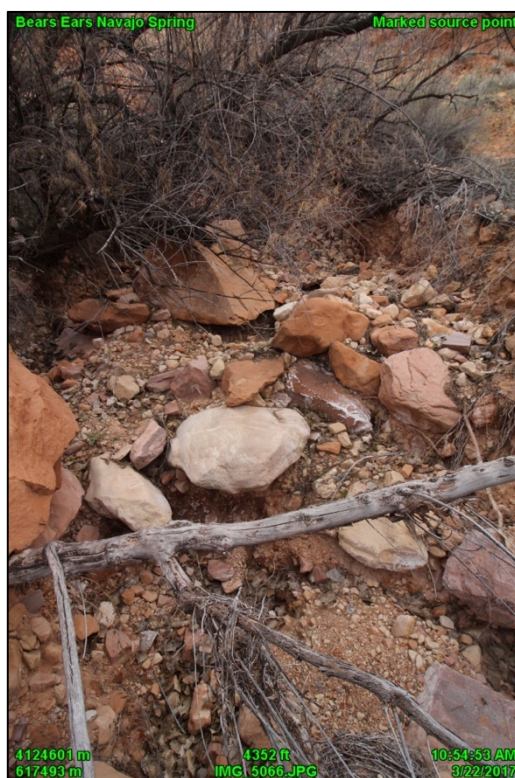
<b>Navajo Spring</b>	
<b>Location</b>	West of Bluff, where Comb Ridge intersects Highway 163.
<b>UTM (at source)</b>	4124601 N, 617493 E.
<b>Hydrology</b>	There is no sign of water, other than some salt crust on the rocks.
<b>Common woody species</b>	Five-stamen tamarisk ( <i>Tamarix chinensis</i> ).
<b>Other woody species</b>	Fremont cottonwood ( <i>Populus fremontii</i> ), rubber rabbitbrush ( <i>Ericameria nauseosa</i> ).
<b>Common herbaceous species</b>	Russian knapweed ( <i>Acroptilon repens</i> ).
<b>Noxious weeds</b>	Five-stamen tamarisk ( <i>Tamarix chinensis</i> ) and Russian knapweed ( <i>Acroptilon repens</i> ).
<b>Vegetation association</b>	Tamarisk species Ruderal Riparian Shrubland.
<b>Wildlife</b>	None observed.
<b>Disturbance</b>	Rock debris from road construction is present, as well as litter and invasive plants.
<b>Condition</b>	Very low condition. This spring does not have much evidence of water or wetland vegetation. It may have been partially buried by rock debris from highway construction above the site. One large cottonwood tree is present, but many non-native plants.
