GRAND CANYON
TRUST

SPRINGS ASSESSMENTS OF BEARS EARS NATIONAL MONUMENT 2018

BY MARC COLES-RITCHIE
JANUARY 2019

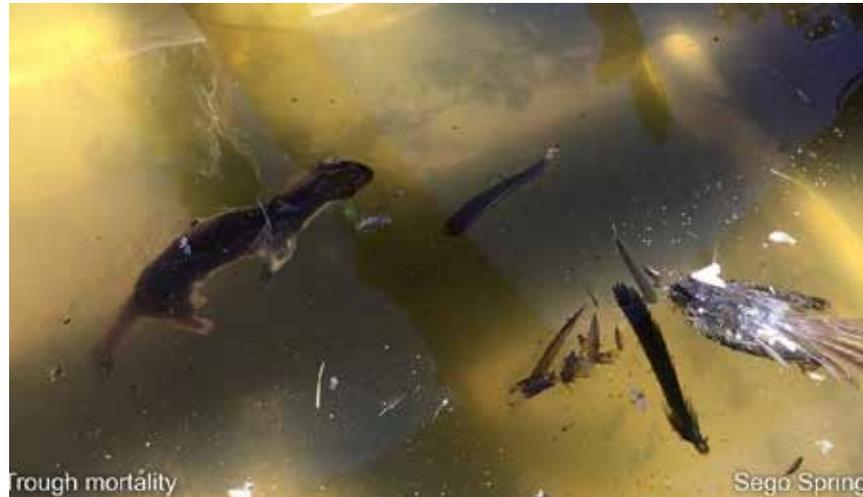
Figure 3. Dead animals (small mammal and bird) in the water trough at Sego Spring, in Cottonwood Allotment, observed June 20, 2018.

Water troughs for livestock were present at 12 sites, two of which were filled with dirt. Escape ramps for wildlife were lacking at eight of the 10 troughs that were functional or potentially functional. Lack of a wildlife escape ramp means small animals and invertebrates are likely unable to exit if they enter the water. Dead animals were observed floating in the water trough at one site (Figure 3).

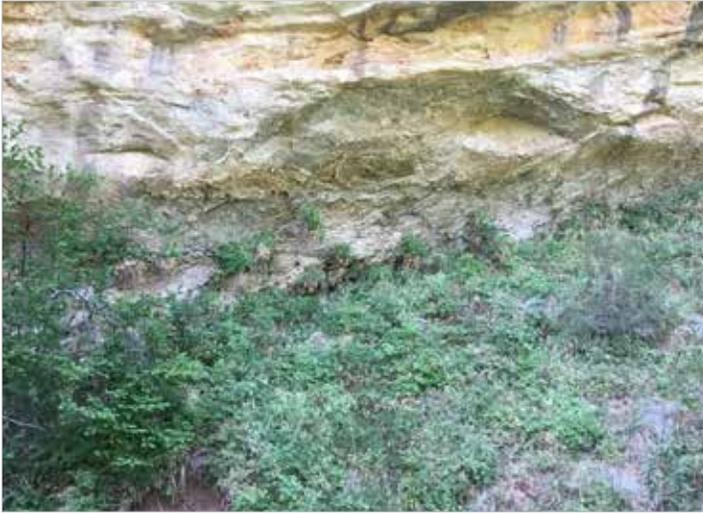
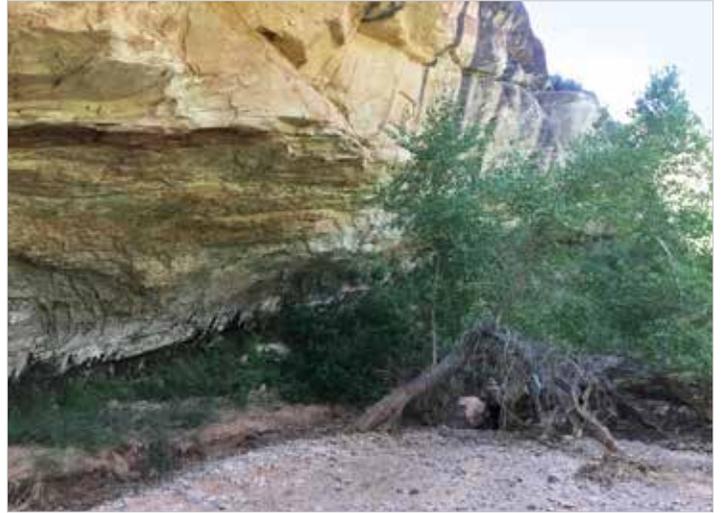
Arch Canyon hanging garden (left) and overview of site and stream channel at base of wet wall (right).

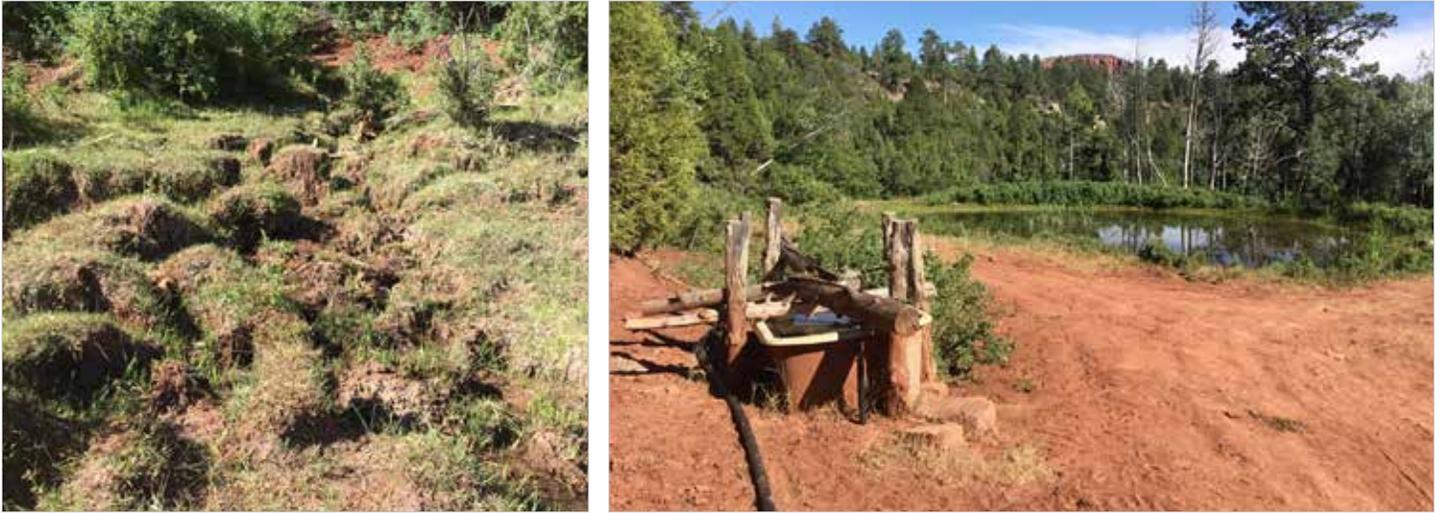
Birch Spring with trampling and pedestals near one of the groundwater discharge points (left) and a trough and pond (right).

Site Condition: Springs are heavily developed and impacted by humans, cattle, and wild ungulates. Severe trampling, pedestals, and hummocks are present at the second natural source and near the northern shoreline of the pond. Water is being pumped out of the pond and over the hill by a generator. A road goes in and around the site.

Restoration Recommendations: Fence off the source that is heavily trampled on the north side of pond. Fence around the pond to exclude cattle; trough can provide water away from tank and pond.

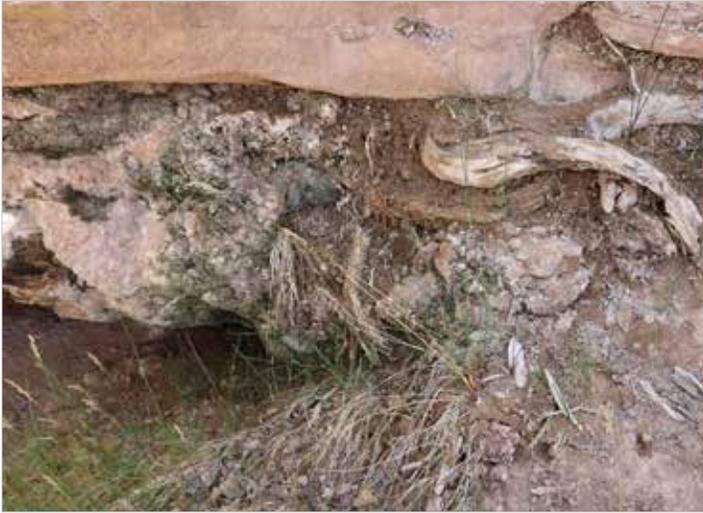
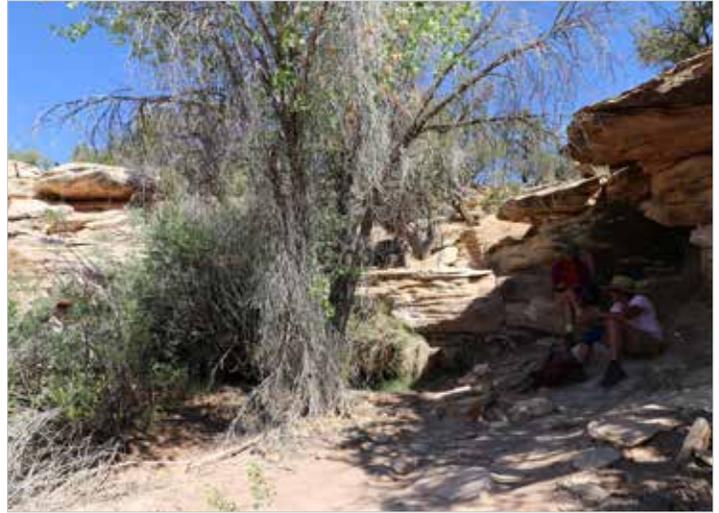
Bullet 1 Spring where groundwater emerges (left), and overview showing cottonwood and willows (right).

Hydrology: There is no surface water, but there is moist soil, wetland plants, and precipitate, which indicate groundwater discharge. About 70 feet away, there is a very small patch of water that comes off the cliff wall.

Site Condition: Hiker disturbance includes trampling, soil erosion, and pedestals because the trail into Bullet Canyon goes through this spring.

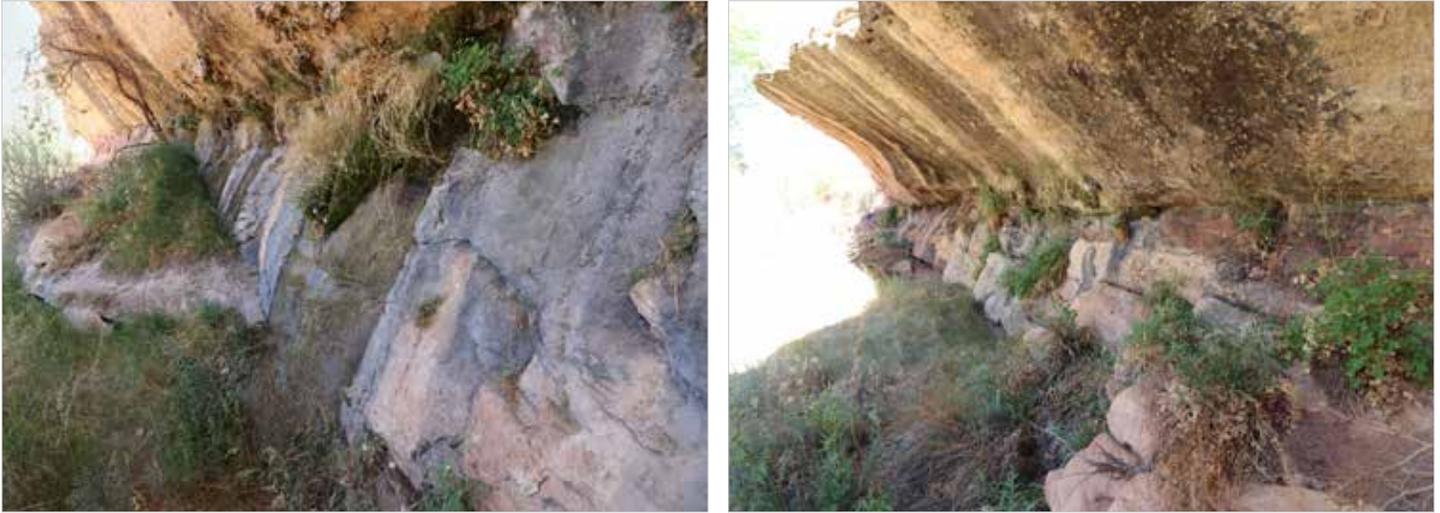
Bullet 2 hanging garden vegetation (left), and overview of site (right).

Site Condition: Good condition with a lot of wetland vegetation on the wet wall. At the base of the wall and in the nearby wash there are some willow and cottonwoods as well as some trampling and cheatgrass*. Evidence of grazing by wild ungulates is present.

Restoration Recommendations: Retain livestock-free status.

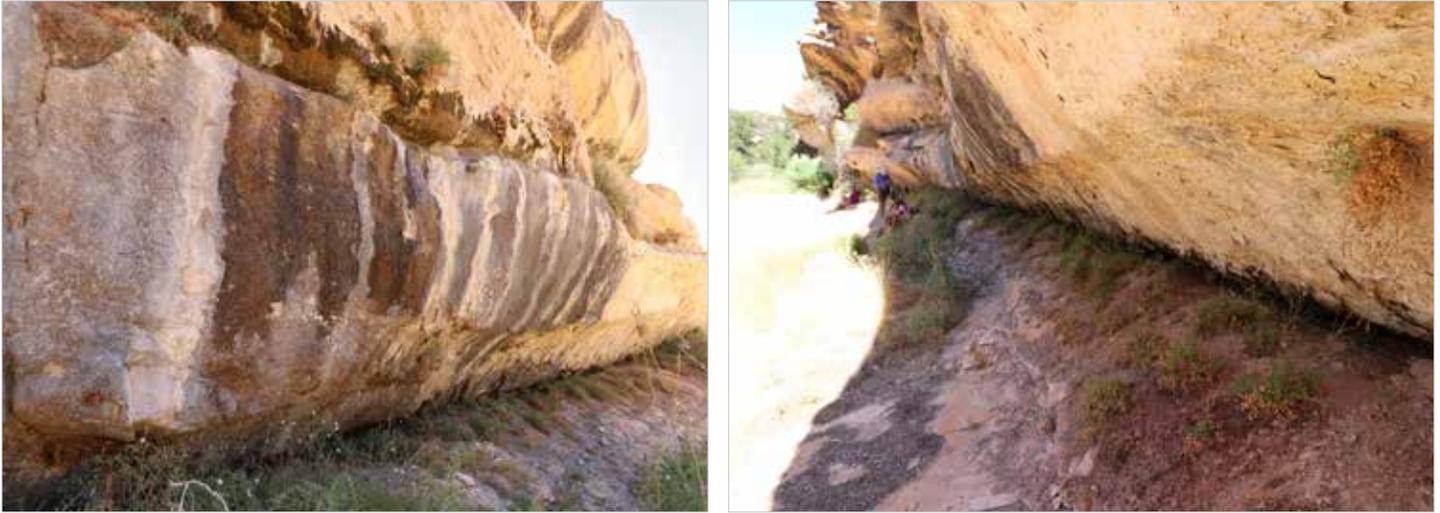
Bullet 3 groundwater emergence that supports hanging garden vegetation (left), and site overview (right).

Site Condition: Very good condition with wetland vegetation on the wall and at the base for about 2 feet. There are human tracks at the base of the wall.

Restoration Recommendations: Retain livestock-free status.

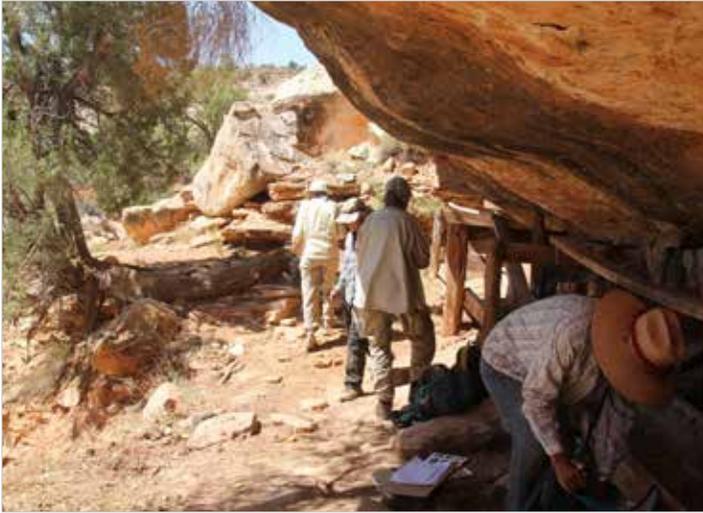
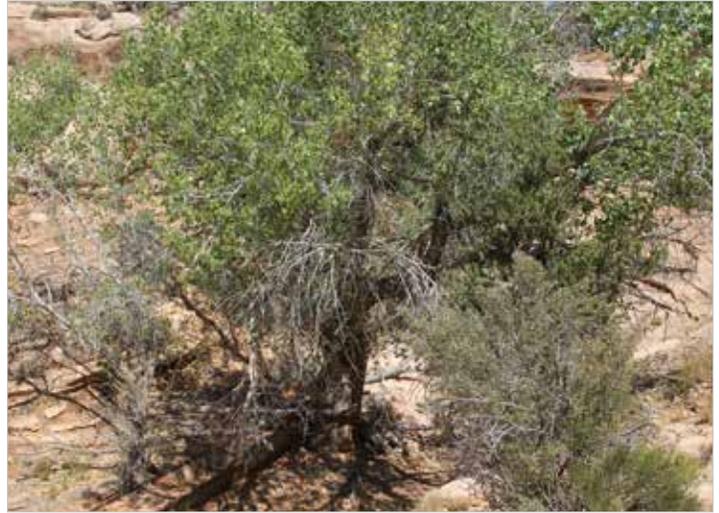
Collins Spring source and wooden catchment (left), and site overview with cottonwood tree (right).

Site Condition: The spring looks heavily used. Water development infrastructure, including fencing, pipes, and a trough, is present but not operational. Trails and trampling by people and cattle are present. The canyon appears to be eroding from flooding and periodic flow.

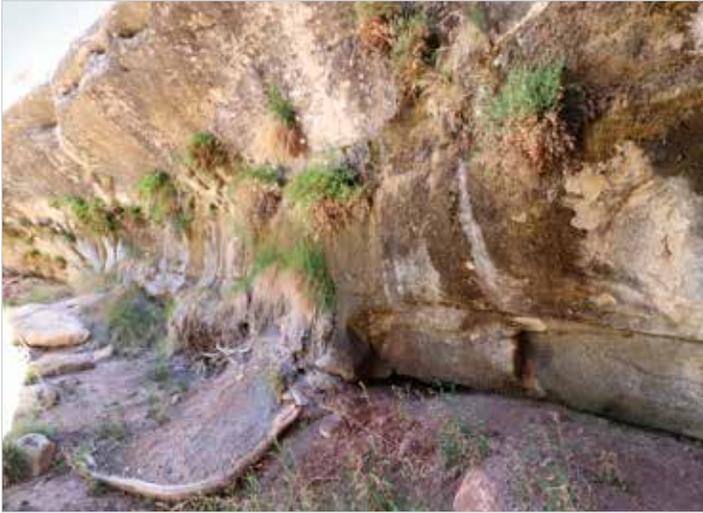
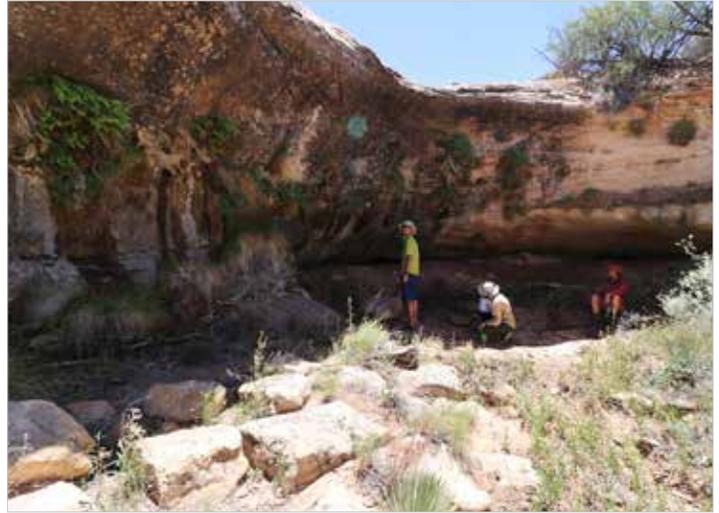
Columbine Cove hanging garden where groundwater emerges (left), and site overview (right).

Site Condition: Good. Seems undisturbed by humans with possibly a bit of trampling by hikers and wildlife.

Restoration Recommendations: Retain livestock-free status.

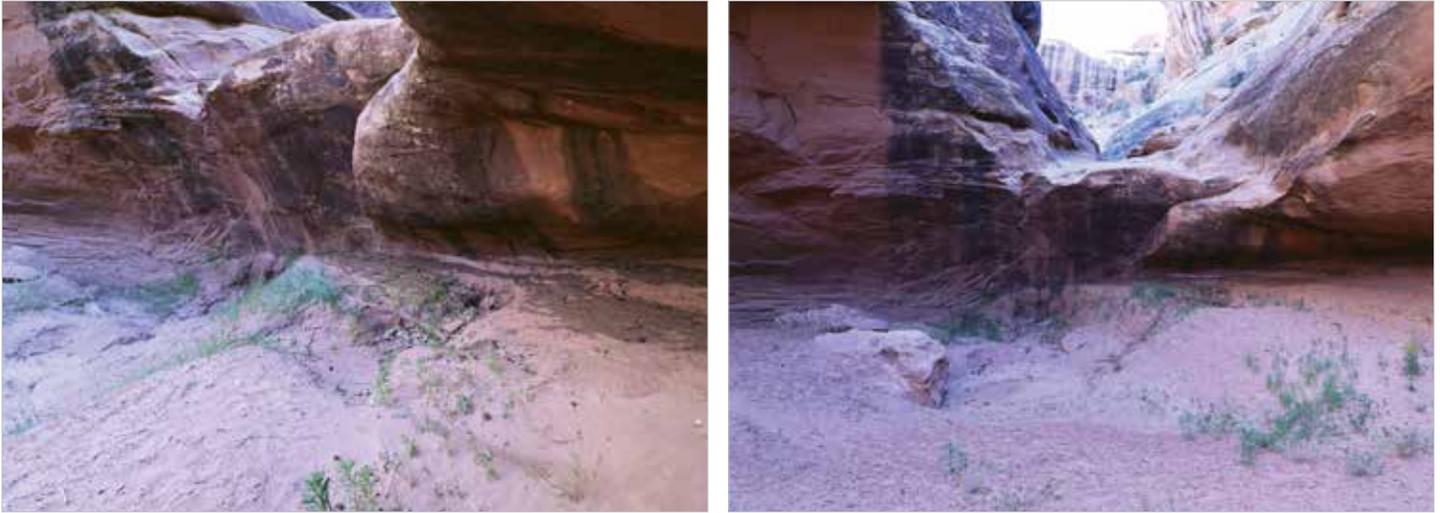
Cow Tank rock spillover (left), and site overview (right).

Site Condition: A dry site that has a small amount of vegetation. Dramatic fluctuation in water and pulse flows likely make it difficult for riparian vegetation to establish and persist.

Restoration Recommendations: Retain livestock-free status.

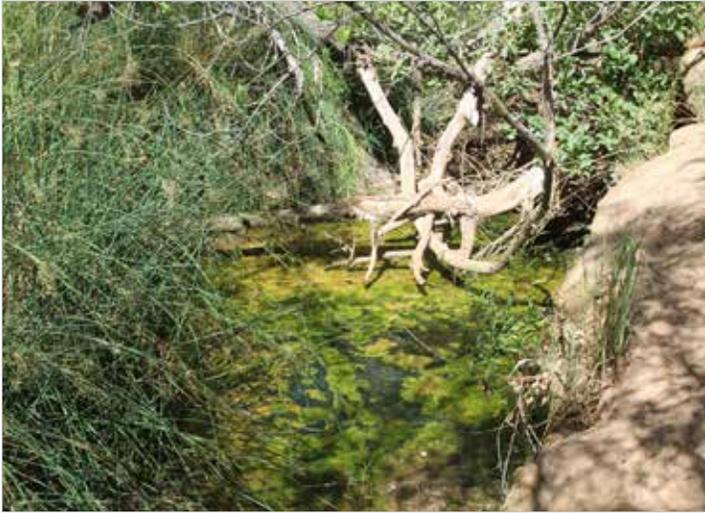
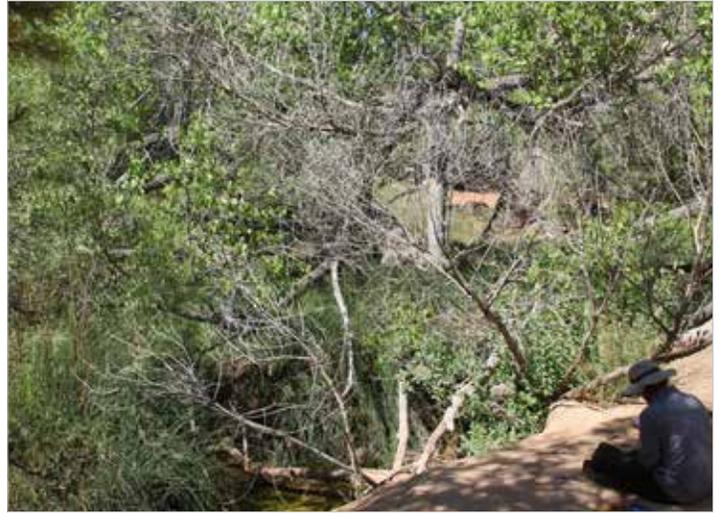
Dog Tanks spring-fed pool (left), and site overview (right).

Site Condition: Good. A pool at the base of a sandstone pourover is surrounded by large cottonwoods, willows, and overhanging vegetation. The wetted reach extends about 60 feet downstream to the campsite and dirt road. Some ungulate grazing and browsing is evident. Disturbance seems minimal.

Restoration Recommendations: Retain livestock-free status.

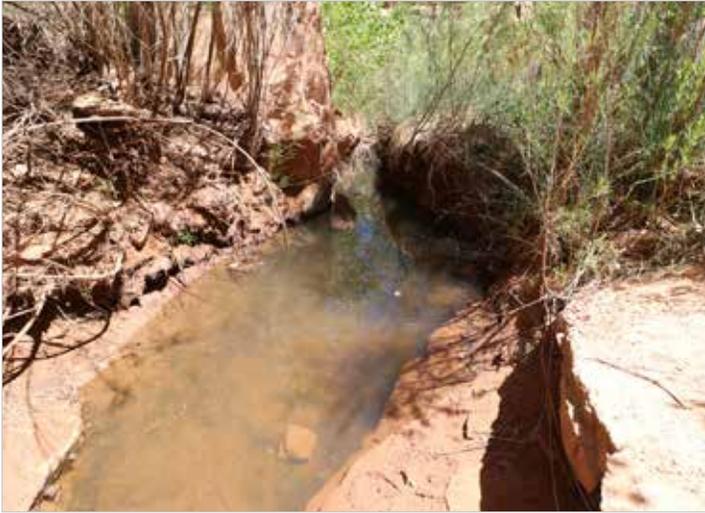
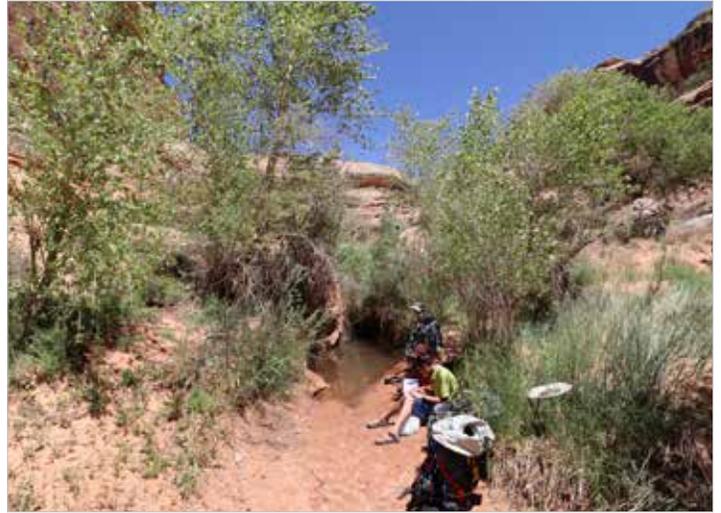
Dripping Canyon Lower pool (left), and site overview (right).

Site Condition: Moderate, with some trampling from wildlife and hikers who access water here. There may be historical channel incision.

Restoration Recommendations: Retain livestock-free status.

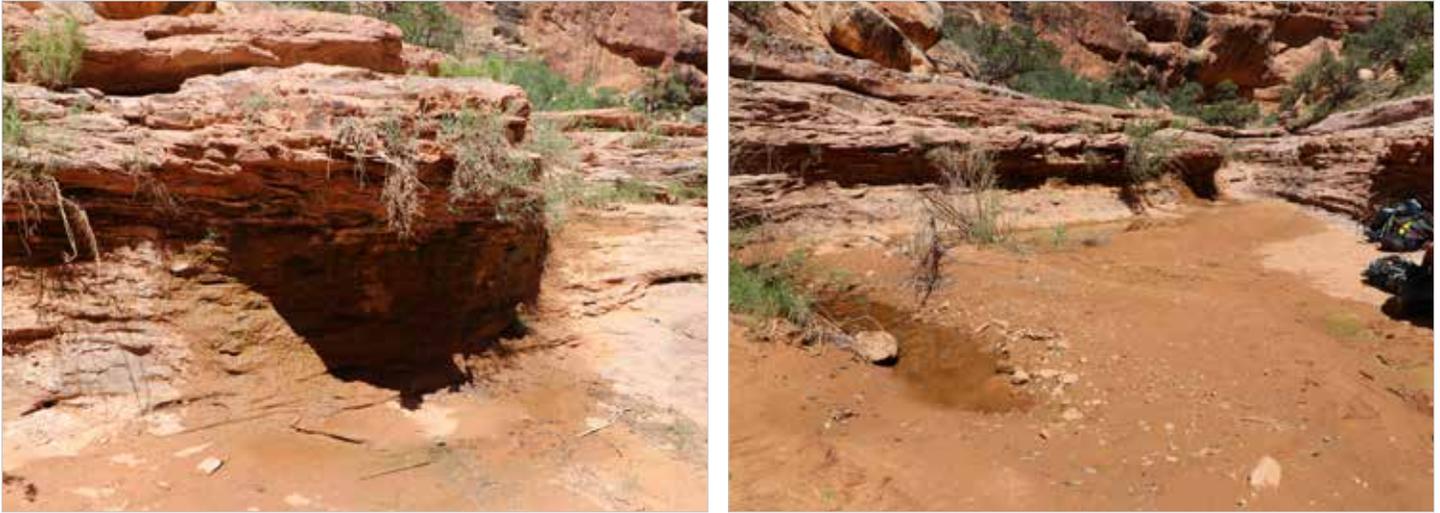
Dripping Canyon Upper Spring, where water drips from rock wall (left), and site overview (right).

Site Condition: Moderate. Spring is impacted by trampling or disturbance from native ungulates, people, and high flows. Vegetation is sparse, considering the water availability.

Restoration Recommendations: Retain livestock-free status.

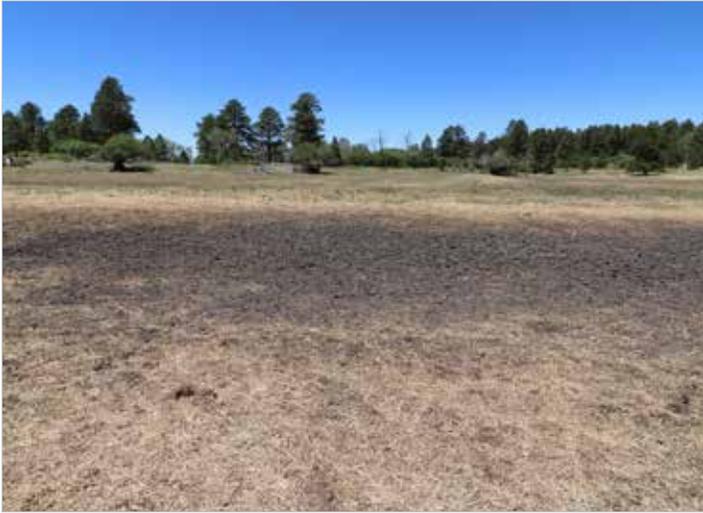
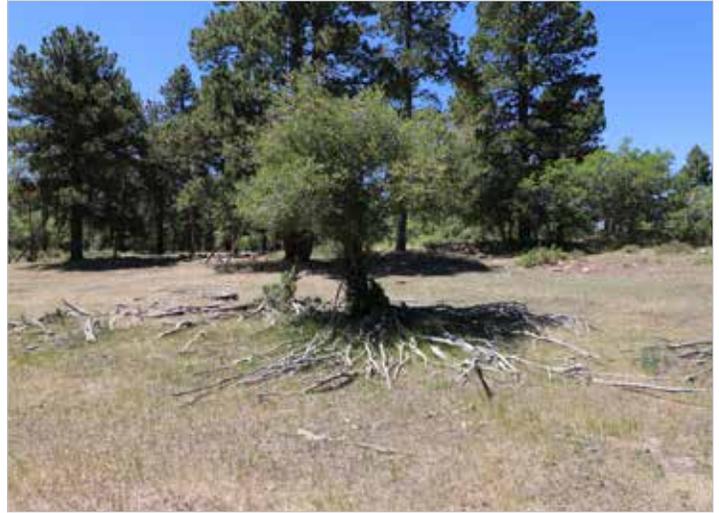
Duck Lake spring site (left), and nearby Bebb's willow that is dramatically overbrowsed (right).

Site Condition: Heavily grazed by elk. The lake seems to have dried up, presumably due to drought. Soil compaction is evident. In the general area, there are two exclosures to protect young Bebb's willow plants and two to protect young aspen. While Gooseberry Allotment has not been authorized for grazing for 18 years, trespass cattle from the Cottonwood Allotment have often gathered in the Duck Lake meadow area through unmaintained boundary fences. The boundary fence was reconstructed in 2014 but breaks in the fence (due to fallen trees or other disturbances) make occasional cattle entry possible.

Restoration Recommendations: Restoration of additional Bebb's willow would require additional fencing. Retain livestock-free status of the allotment.

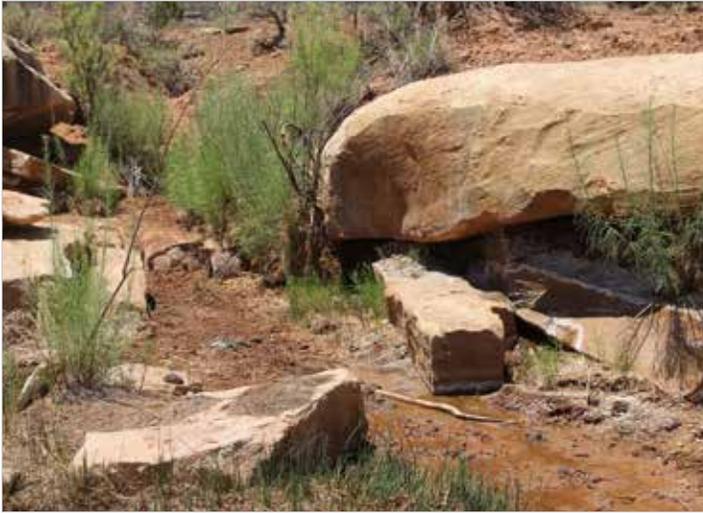
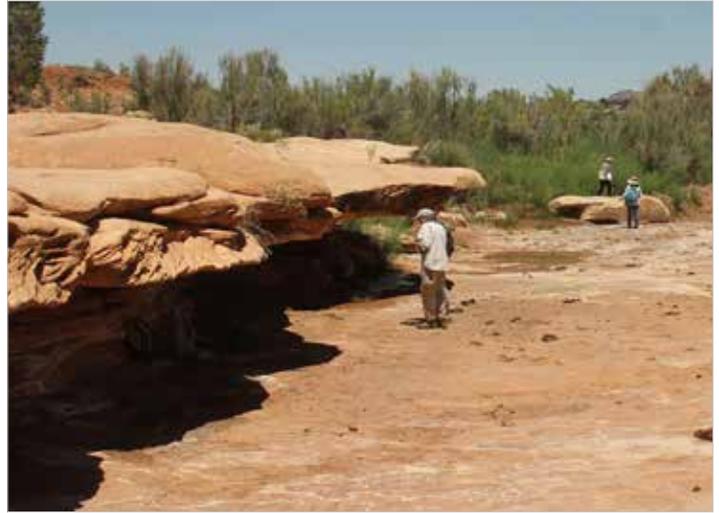
Fry (113) groundwater emergence (left) and site overview (right).

Site Condition: Heavily used by cattle, with evidence of soil erosion, compaction, excavation, grazed cattails, and browsed willows.

Restoration Recommendations: Fence the area to exclude cattle and allow the vegetation to recover.

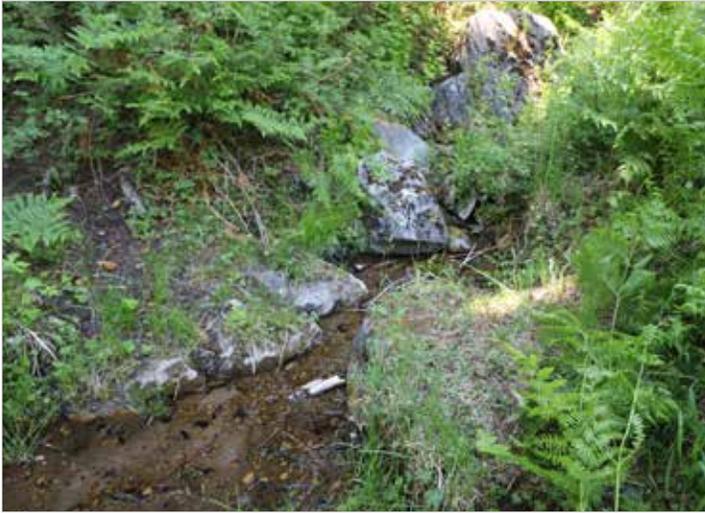
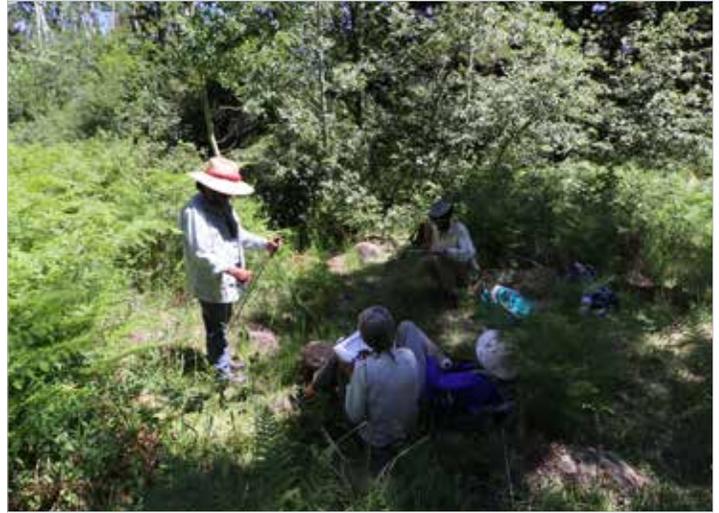
Spring U.S. Forest Service 5094 where groundwater emerges from pipe (left), and site overview (right).

Site Condition: The source is somewhat protected by the log fence enclosure, but that is a relatively small area. The site is heavily grazed outside of that enclosure, where weeds are abundant. The soil is compacted, eroded, and pedestaled. Water is diverted to the trough. The surrounding area is a relatively healthy aspen forest that includes young and old trees.

Restoration Recommendations: Retain livestock-free status of the allotment.

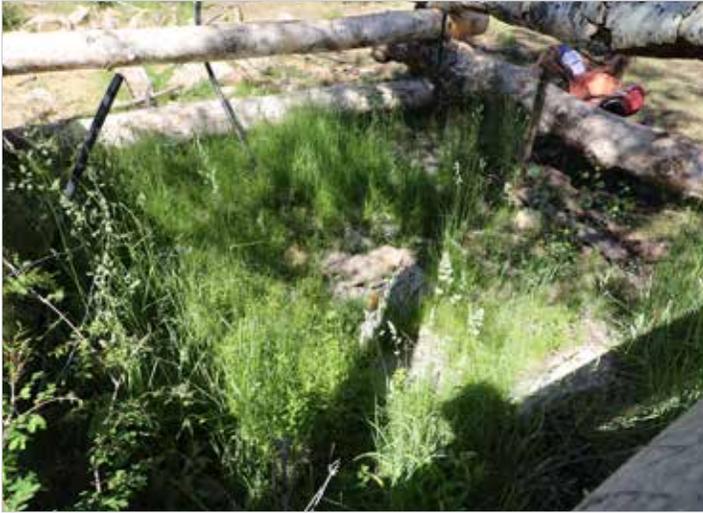
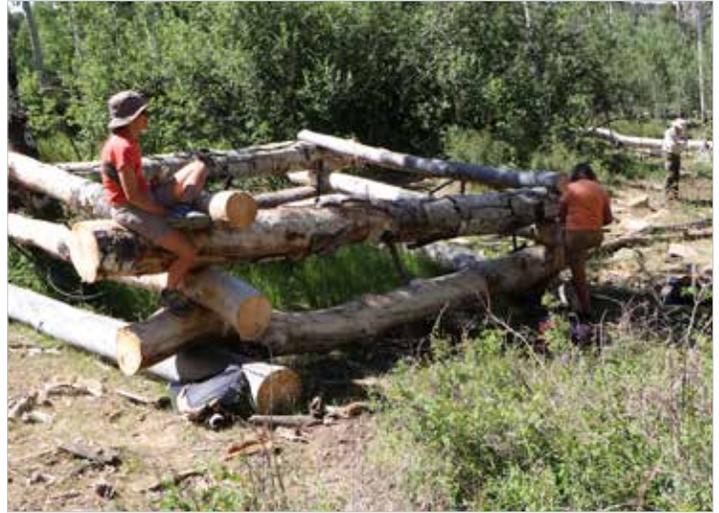
Spring U.S. Forest Service 5145 source surrounded by log enclosure fence (left), and site overview including pipes on ground leading to trough (right).

Restoration Recommendations: Improve fence for the larger area. Current fence is not fully functional and the area is trampled, weedy, and bare. The log fence around spring is very effective, with much wetland vegetation, but it is only about 150 square feet.

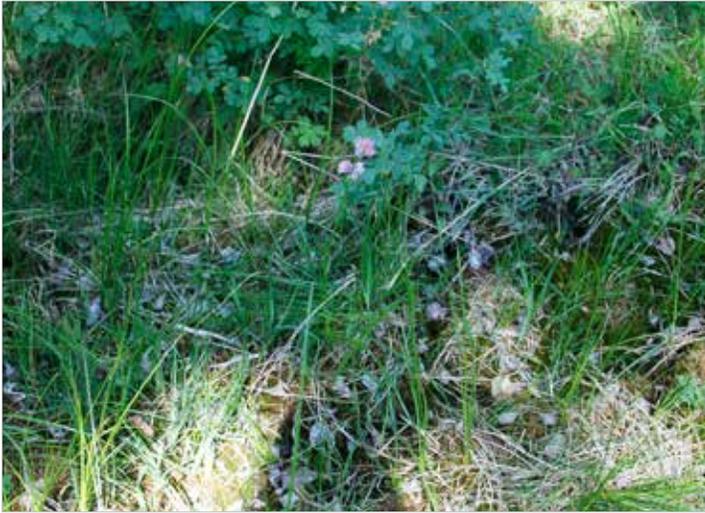
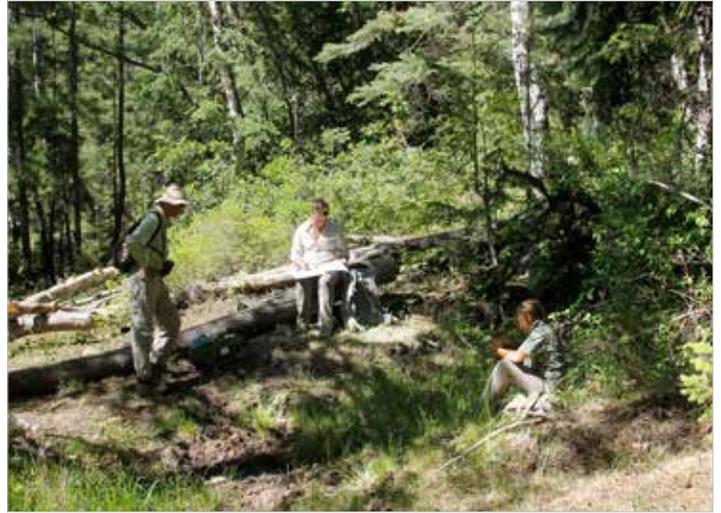
Spring U.S. Forest Service 5160 source location (left), and site overview (right).

Restoration Recommendations: Retain livestock-free status of the allotment. Remove the piping and trough.

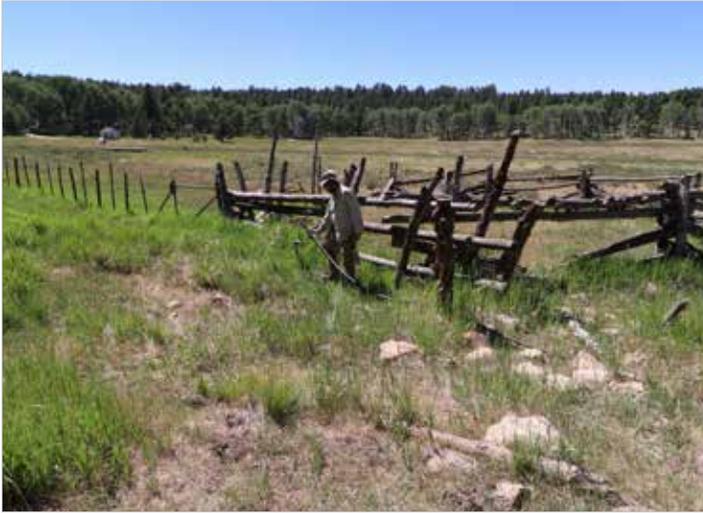
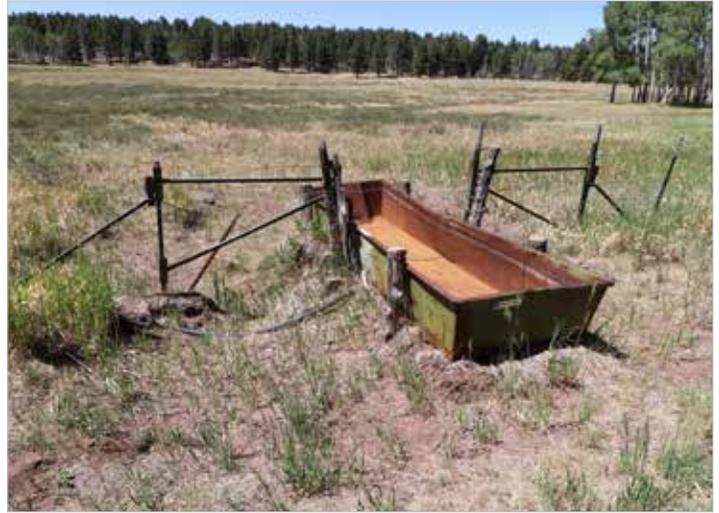
Gooseberry Guard Station spring site (left), and dry water trough (right).

Site Description: Dry. There are two long-unused troughs and pipes, but no water. There is a fenced meadow with shrubby cinquefoil, which indicates some soil moisture. There is a small corral.

Site Condition: The site looks like it has been disturbed by livestock and human activities associated with the Guard Station, including the fence, road, which is about 30 feet from the trough, and water diversion infrastructure.

Restoration Recommendations: Retain livestock-free status of the allotment.

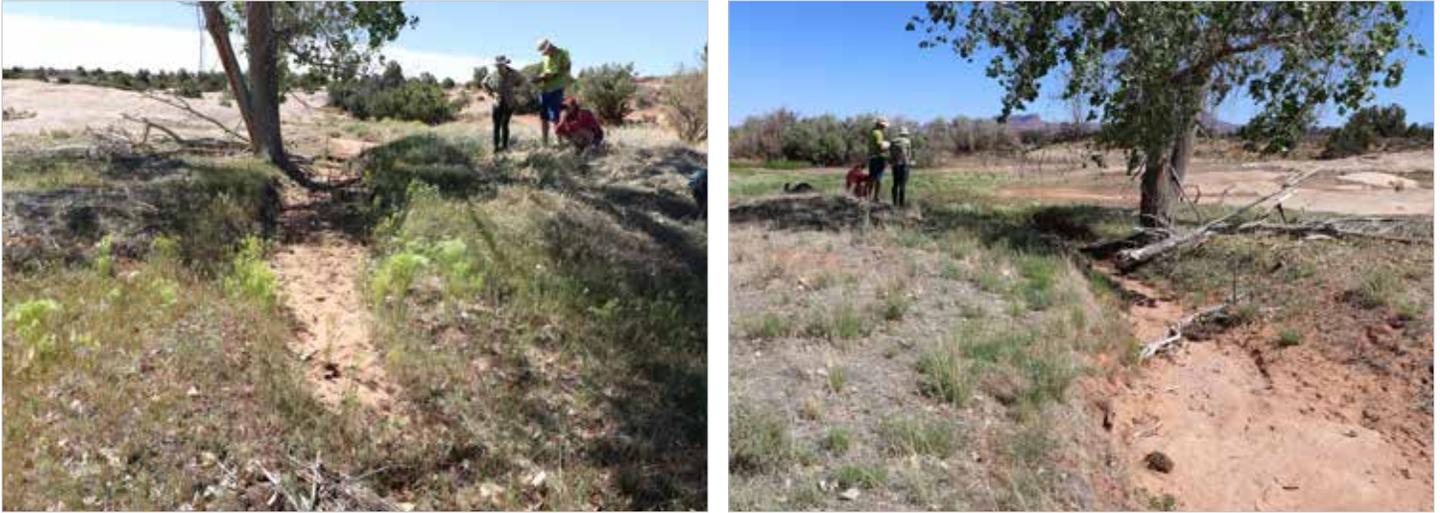
Government Trailhead Spring source (left) and site overview (right).

Site Description: A moist meadow with wetland graminoids and patches of willow and cottonwood. A berm probably helps sustain this wetland in wetter periods, and may have been created to provide water to livestock. There are four old cottonwood trees.

Site Condition: Wetland vegetation is abundant but no surface water was observed. The dense vegetation stands out in this dry setting. Some impacts from grazing, such as trails and trampling, are present but they seem to be old. Government Trailhead is a few hundred feet away.

Restoration Recommendations: Fence this spring-wetland.

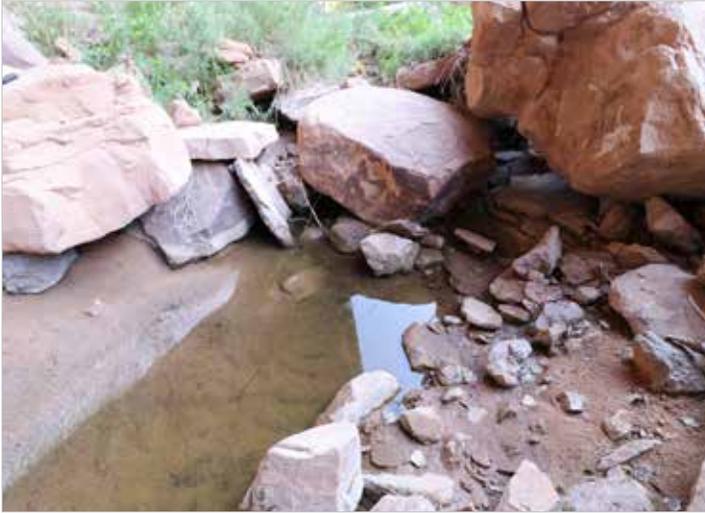
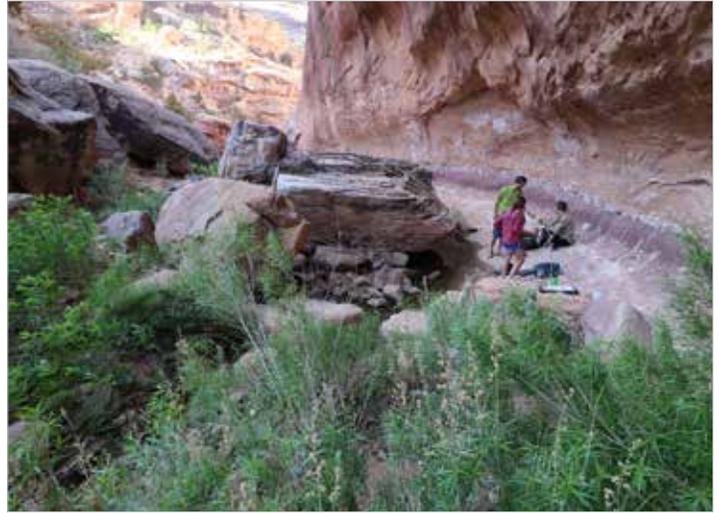
Green House Canyon Main Spring source (left) and site overview (right).

Site Condition: Moderately good condition although there are some human impacts from hikers accessing water. High flows create disturbance. Some tamarisk* are nearby.

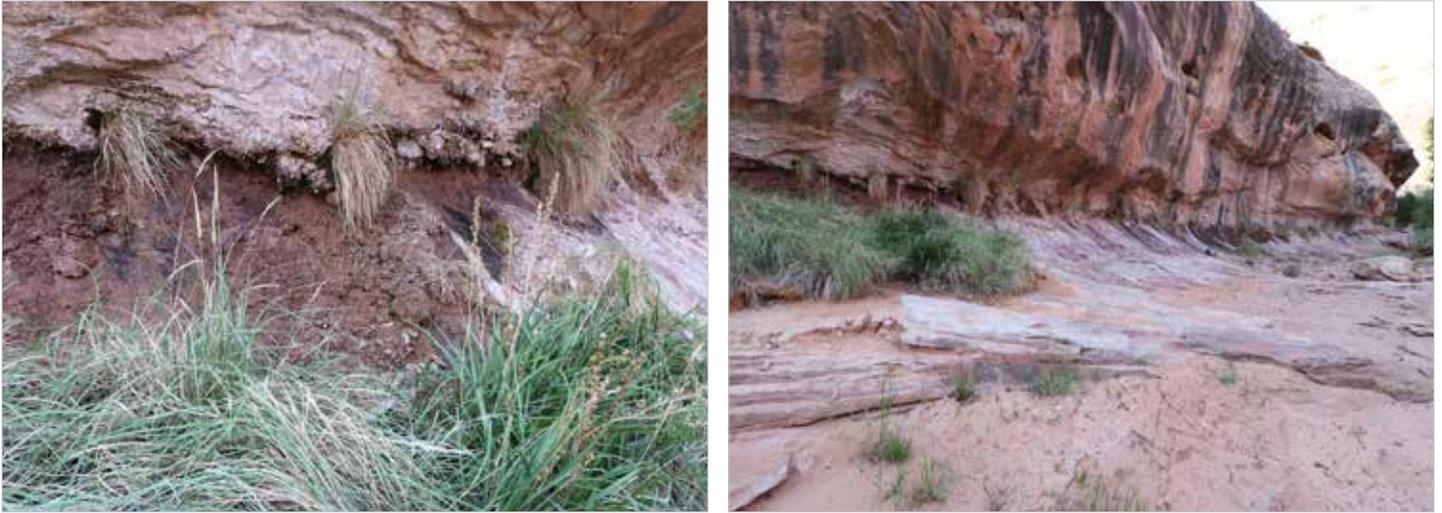
Green House Canyon, Salted Rainbow Spring source (left) and site overview (right).

Site Condition: Good condition hanging garden with robust wetland vegetation.

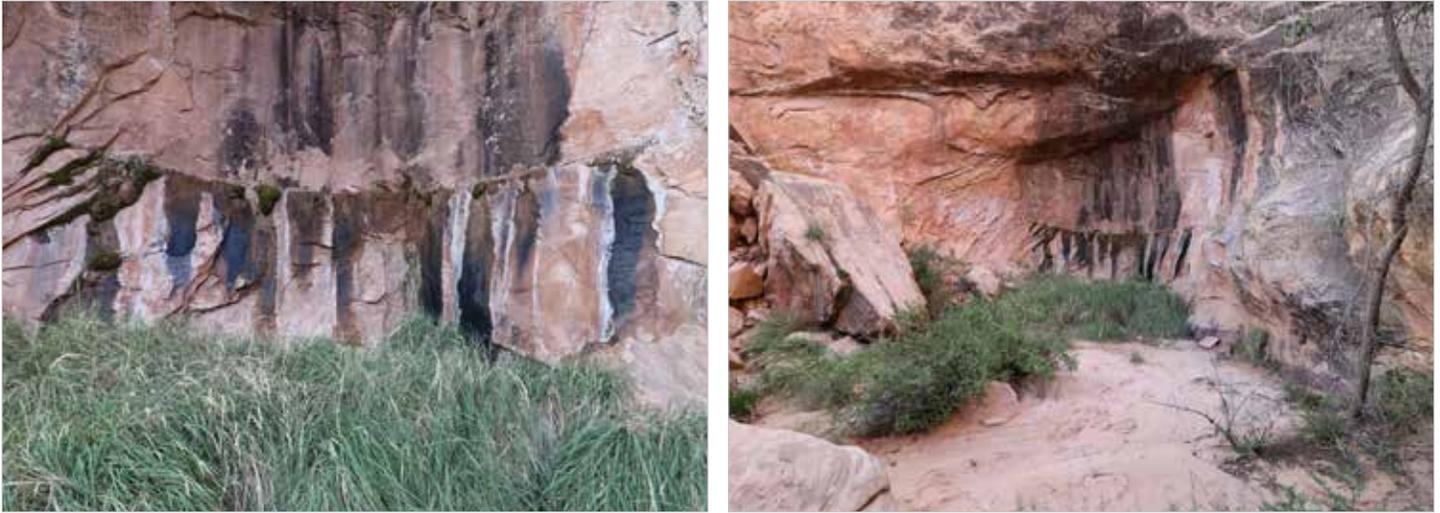
Green House Canyon, South Side Canyon spring source (left) and site overview (right).

Site Condition: Very good. There is minor nearby evidence of trails by animals or people.

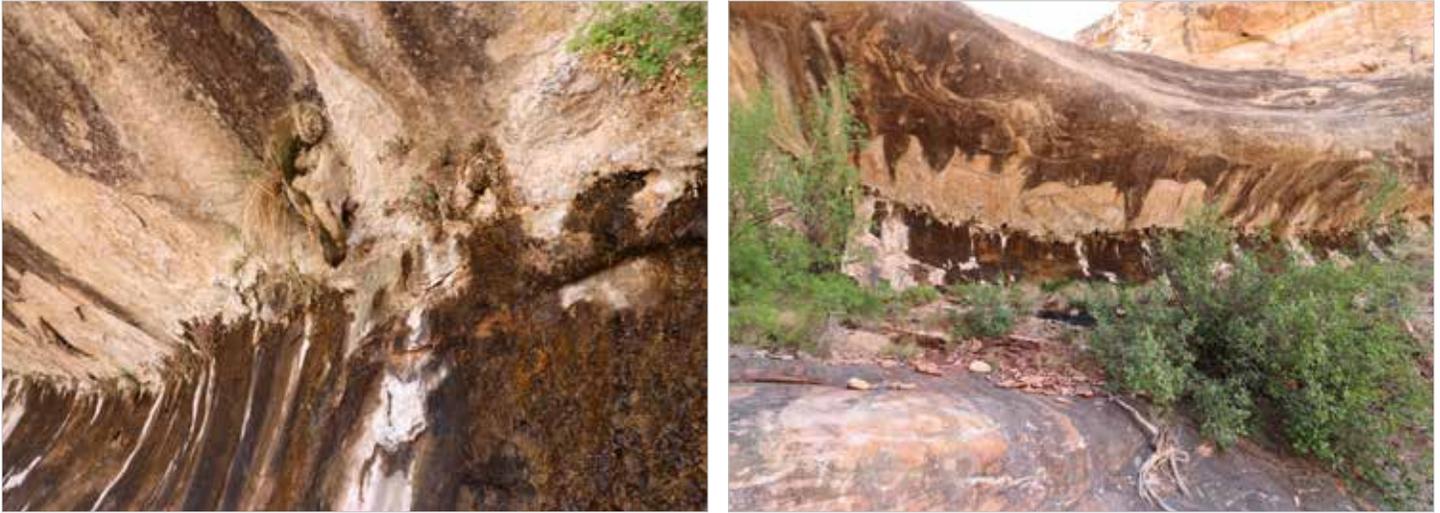
Green House Canyon, Upper South Side Canyon wet well with precipitate and hanging garden plants (left) and site overview (right).

Site Condition: Great. Vegetation present on the wet wall.

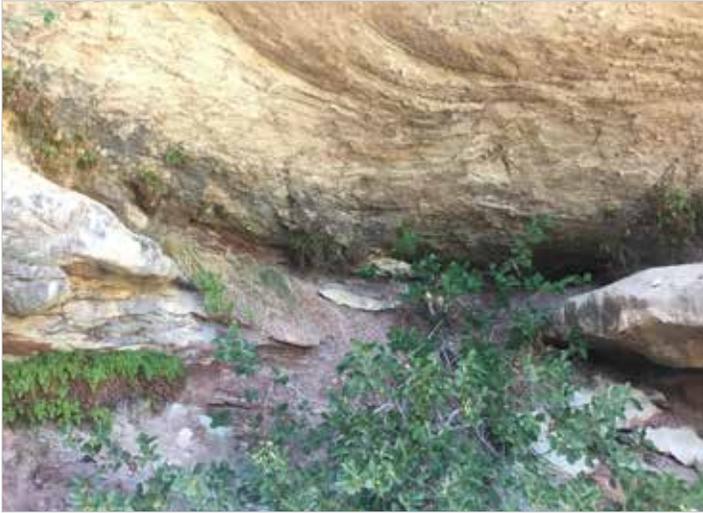
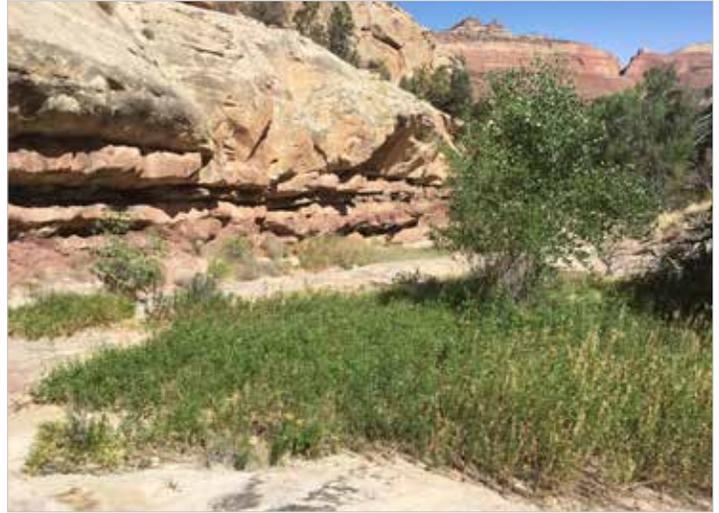
Hwy 95 Spring wet wall (left) and site overview (right).

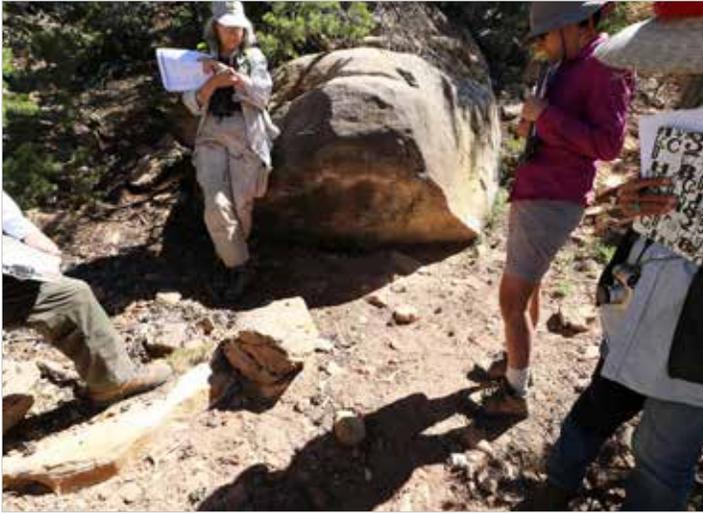
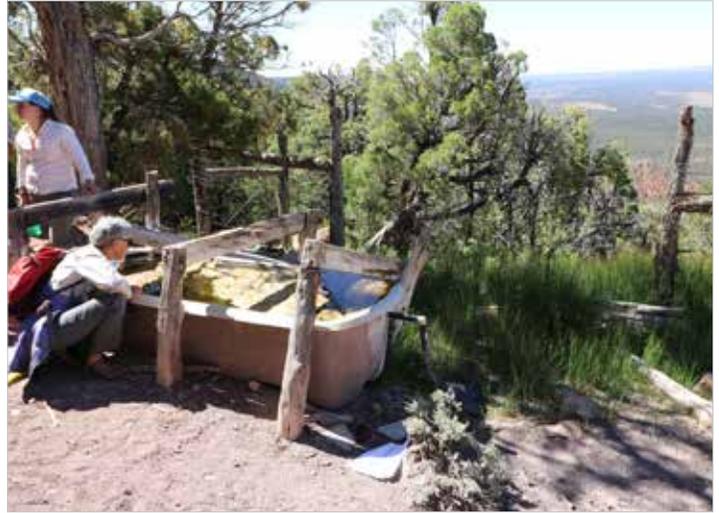
Maverick Spring with pipe coming from ground (left) leading to trough that overflows to hillslope wetland (right).

Site Condition: Good condition in the enclosure with dense wetland graminoid vegetation. The tall fence works well to protect the wetland. Area outside the enclosure is highly impacted, with signs of trampling, trails, and grazing. It looks like there was an older fence that used to be a larger enclosure. An old road goes through the upper edge of the spring area where the trough and pipes are located. An old outhouse remains below the site. Grazing around the enclosure has caused soil erosion, compaction, and some pedestaling.

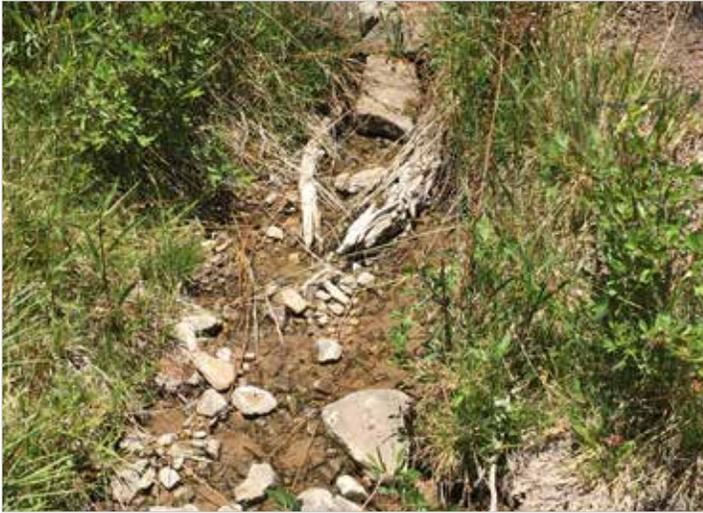
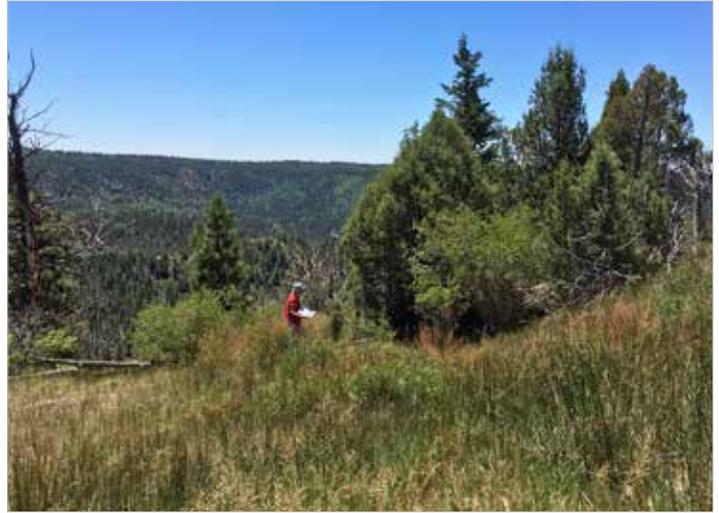
North Notch Spring source (left) and site overview (right).

Site Condition: There is a steady flow and prevalent riparian vegetation. Past diversion of water led to a trough. There is log fencing on two sides but that does not exclude ungulates. Fencing continues down slope in a lower cienega. Some soil erosion and compaction was observed. A road leads to the edge of the spring fencing.

Restoration Recommendations: Improve fencing by road; retain livestock-free status of the allotment.

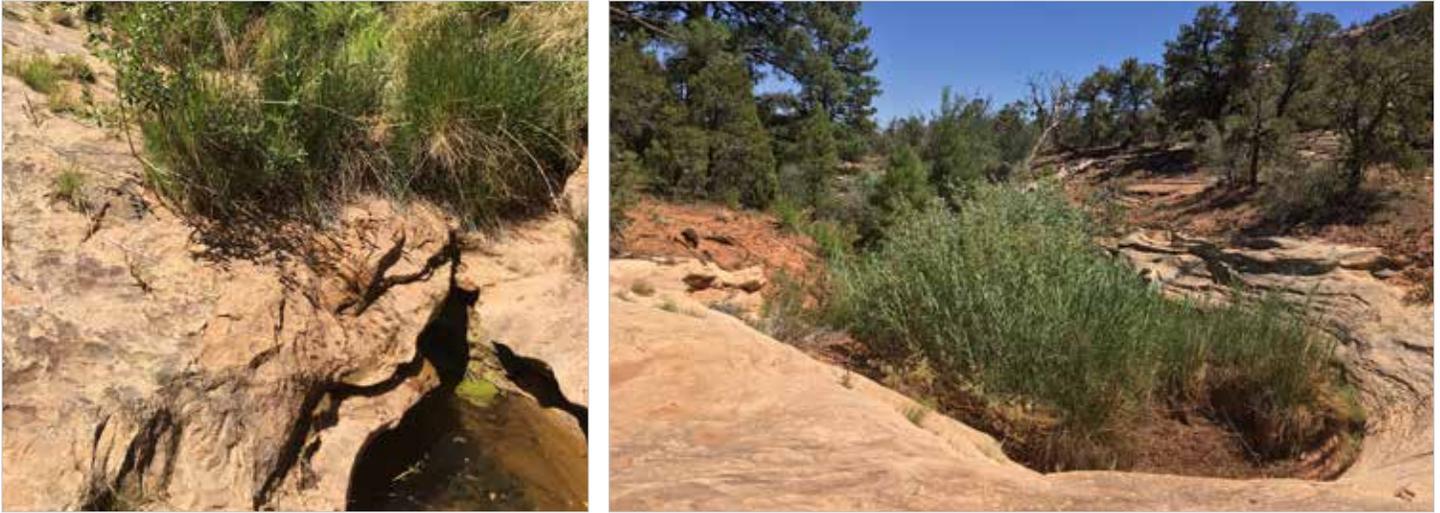
Pine Spring source (left) and site overview (right).
