GRAND CANYON
TRUST

SPRINGS ASSESSMENTS OF BEARS EARS NATIONAL MONUMENT 2018

BY MARC COLES-RITCHIE
JANUARY 2019

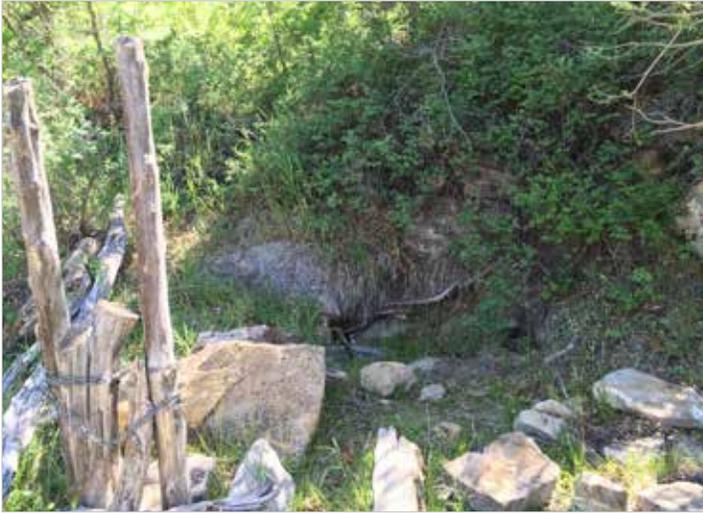
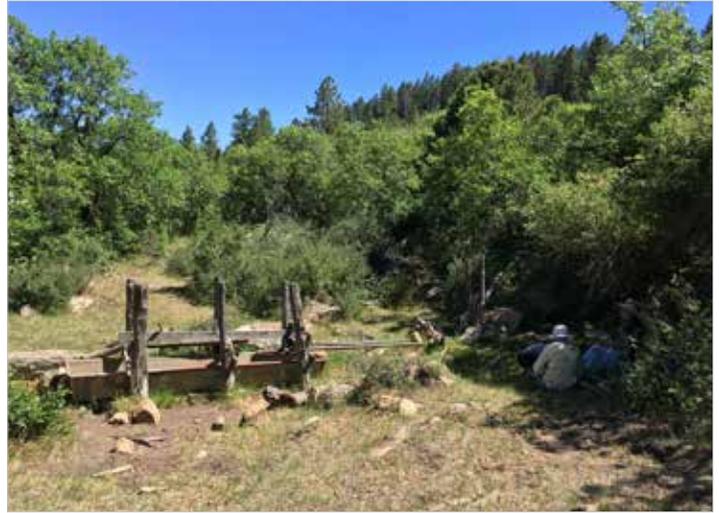
Posey Spring source (left) and site overview (right).

Site Condition: Impacts from cattle and wild ungulates include grazed plants, trampling, and soil compaction. An all-terrain vehicle trail is nearby. Pipes are broken. Excavation may have been done in the past.

Restoration Recommendations: Fence the area to allow vegetation to recover.

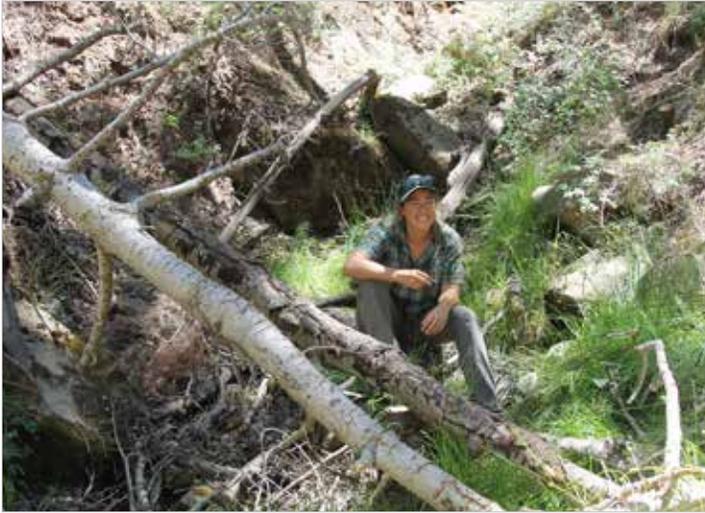
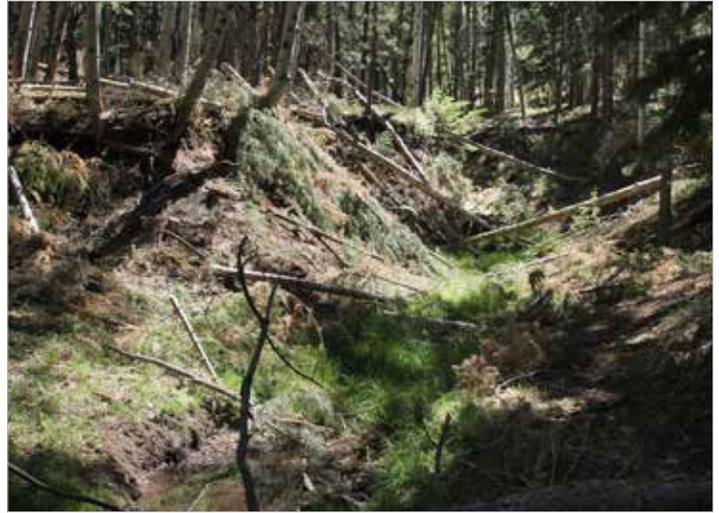
Poso Spring source (left) and site overview (right).

Site Condition: The slopes along the channel are highly eroded. Species richness seems low; only one veronica and some grasses. Mannagrass is abundant and sedges are common. Significant tree cutting, particularly ponderosa pine and white fir has occurred recently, apparently as a thinning effort. Some cut trees are still green. Fallen trees are in the wash. Trails, soil compaction, and erosion from animals and/or people are present.

Restoration Recommendations: Retain livestock-free status of the allotment.

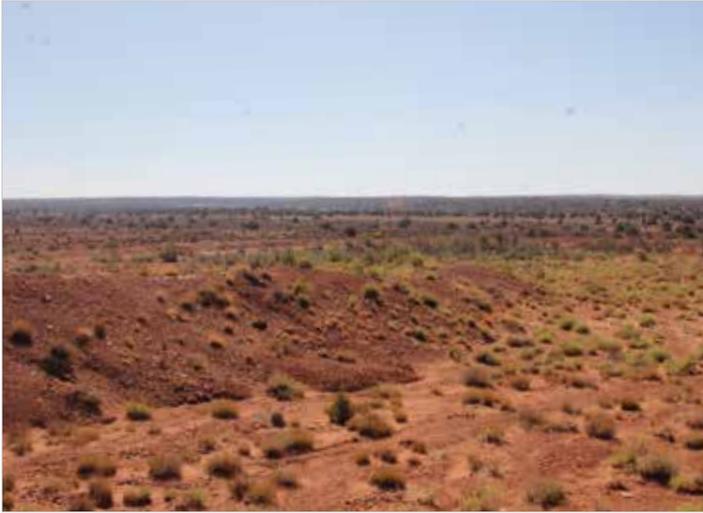
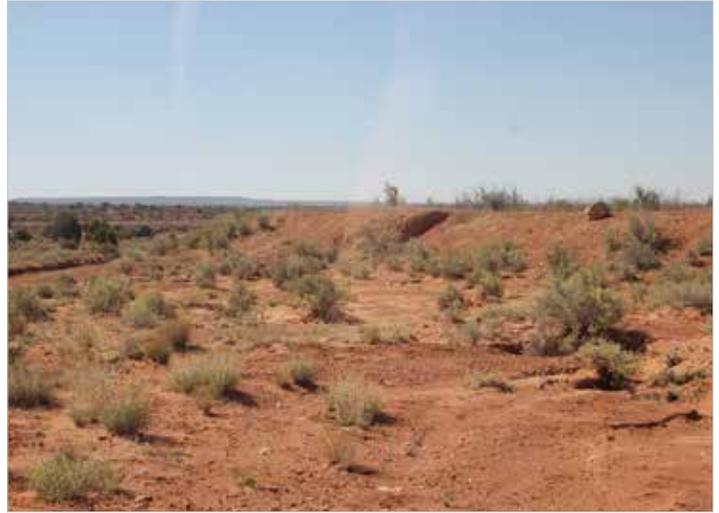
Red House site overview with evidence of old berm (both photos) which may have impounded water in the past.

Site Condition: The site is dry and there is evidence of grazing and trampling by ungulates as well as excavation by people.

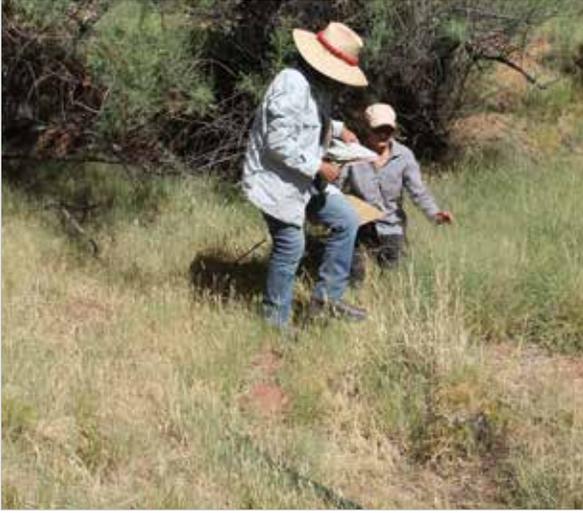
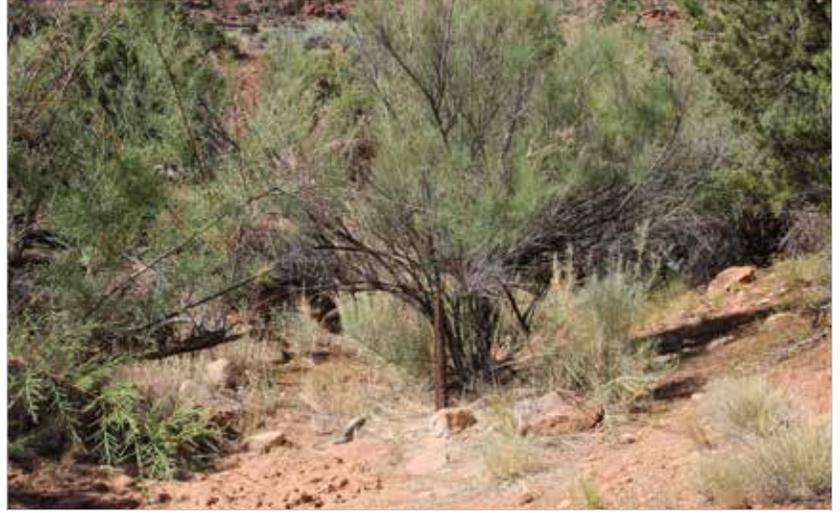
Rock Spring apparent source (left) and site overview (right).

Site Description: A dry site with 3-inch diameter black plastic piping buried at the apparent source. Bricks are present. A pipe runs for about 100 feet to a small catchment pond. Cattle trails, a salt block, and unknown farm equipment were observed. A major highway culvert drains parallel to the spring channel, which is highly eroded. The surrounding vegetation is Utah juniper, piñon pine, cliffrose, Fremont barberry, Navajo yucca, and single leaf ash. There is also biocrust.

Site Condition: There is no surface water, but there is evidence of past water presence. Tamarisk* is present near the source. A small channel with piping leads to a dried pool with cattle tracks. Two T-posts are near the pipe outlet. There is trash at the site, and salt blocks are nearby. A road is above the spring source. Evidence of channel erosion, general erosion, and soil compaction by cattle and people is present.

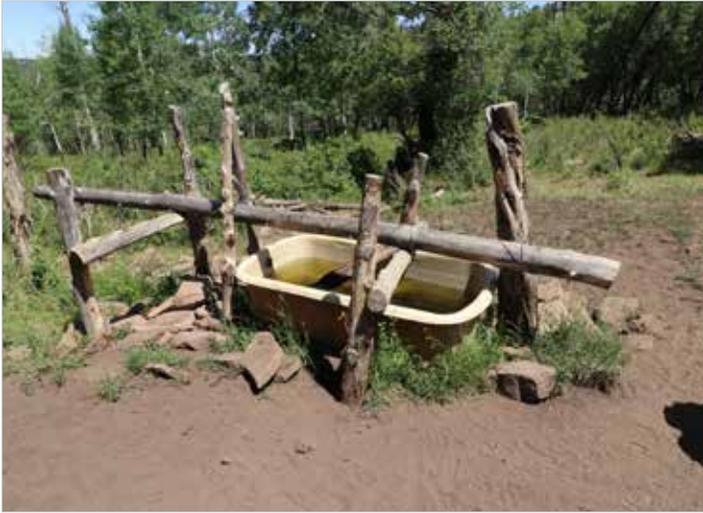
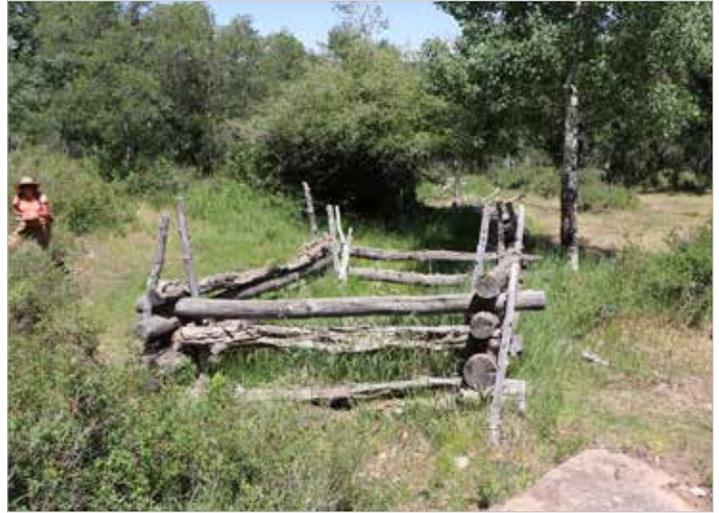
Sego Spring source surrounded by log fence (left) and site overview (right).

Site Condition: Site is heavily impacted by cattle, elk, and deer. There is much bare ground, soil compaction, and erosion. A small area around the source is somewhat protected by a log fence. The site is adjacent to the allotment boundary fence, which is intended to keep cattle outside the White Mesa Cultural and Conservation Area (Gooseberry Allotment). The fence and proximity to the ungrazed allotment probably increases animal visitation to this spring. A large, old Bebb's willow is heavily browsed on the lower part of the plant. A game camera and salt lick were observed.

Restoration Recommendations: Fence a larger area of the spring and wetland area with better fence; current fence is made of old logs. Remove old infrastructure.

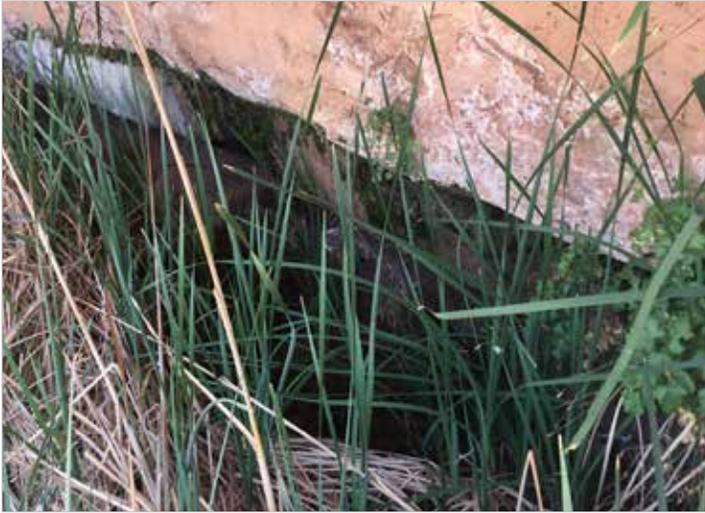
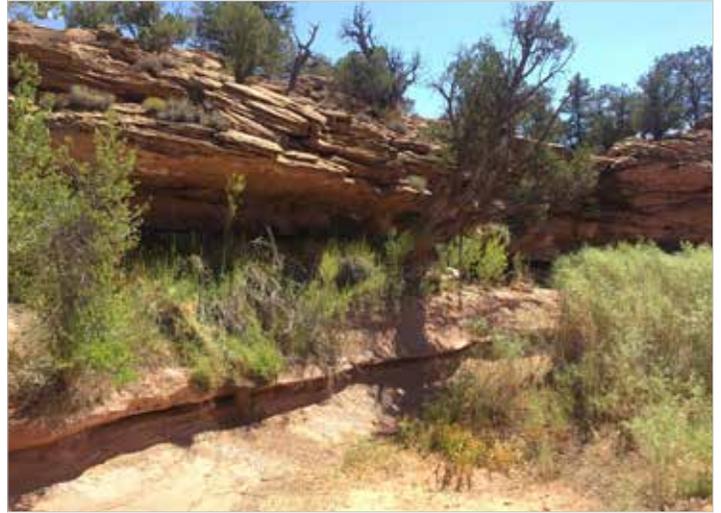
Snow Flat 1 Spring source (left) and site overview (right).

Site Condition: Excellent. The only disturbance is a small earthen water impoundment on the west side of the spring. No invasive plants were observed.

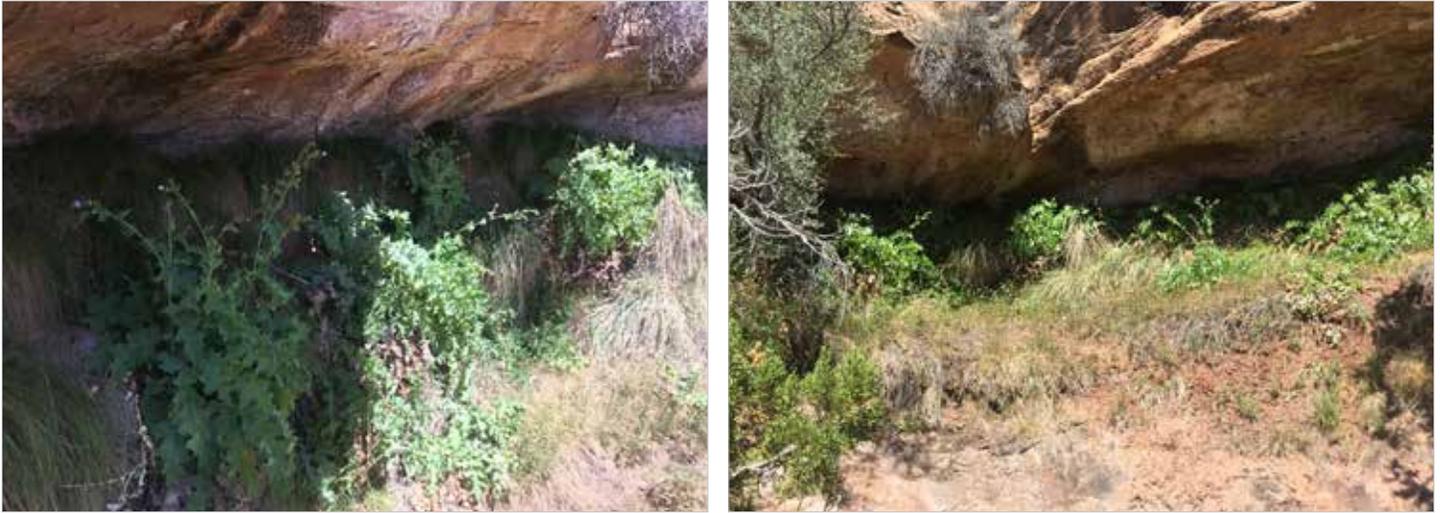
Snow Flat 2 Spring source (left) and site overview (right).

Site Condition: There is wetland vegetation, but no surface water was observed. No significant disturbances were observed.

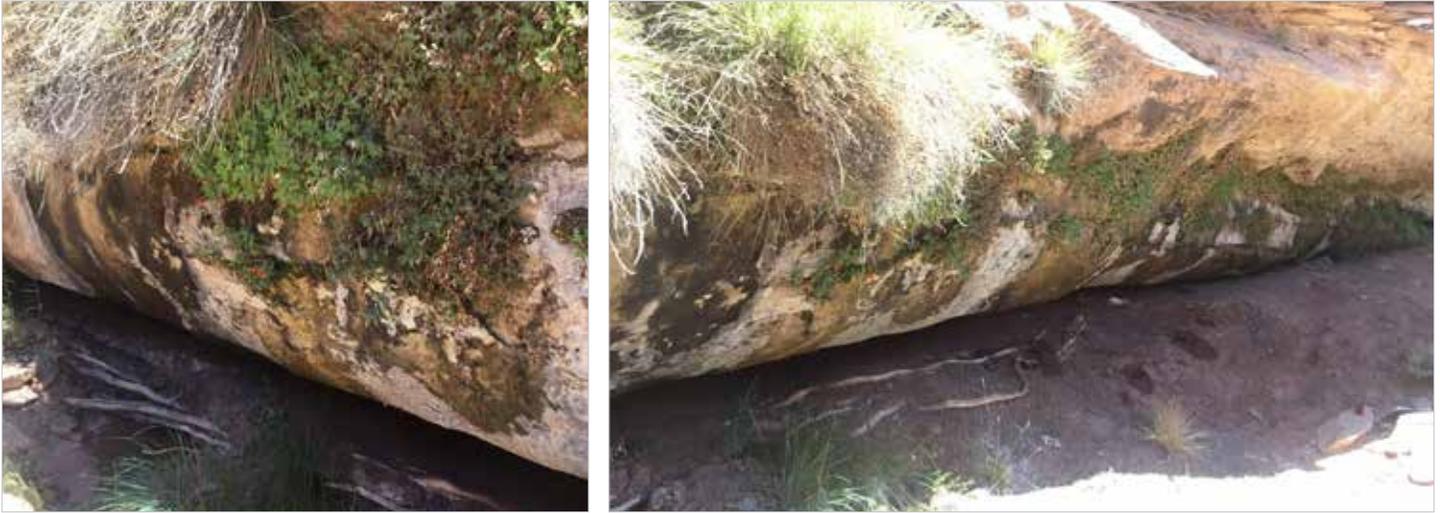
Snow Flat 3 wet wall close-up (left) and site overview (right).

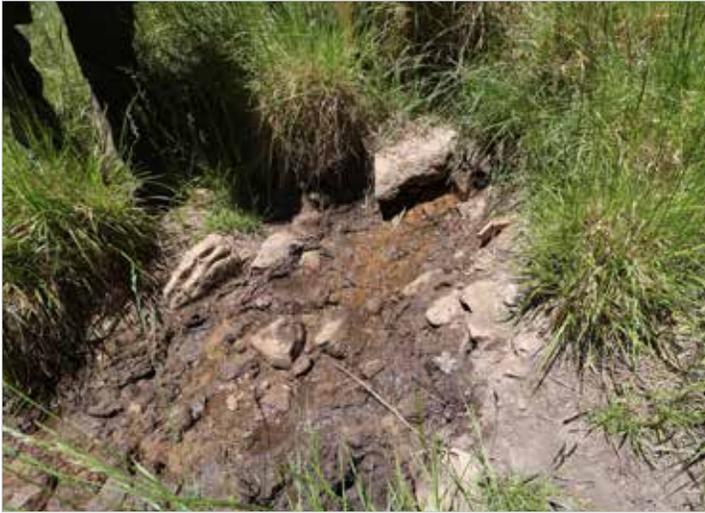
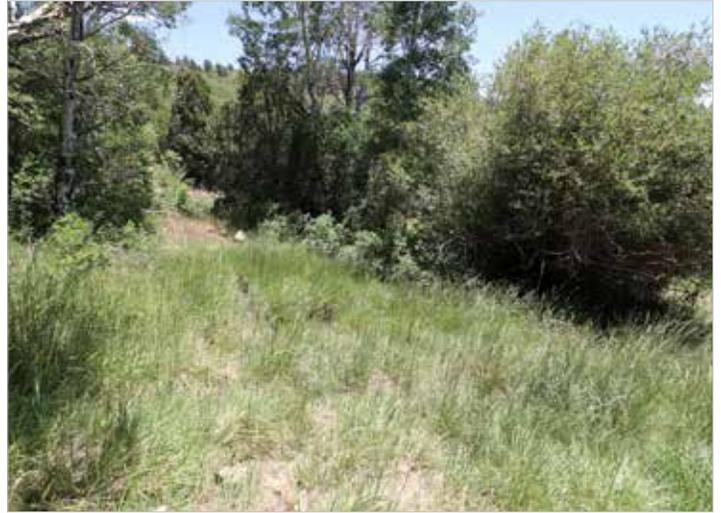
Spring 11 source (left) and site overview (right).

Site Condition: Relatively good condition. There is a small, but steady, discharge of water which supports a graminoid wetland with riparian shrubs and trees further down. There is water development infrastructure, including pipes, fences, and a trough, that only partially function, if at all. There is a bit of channel erosion and pedestals but the wetland vegetation is abundant. The lower wetland area is heavily grazed and trampled by deer and/or elk.

Restoration Recommendations: Fence the area to allow for recovery of the wetland vegetation in the lower section that is trampled by elk.

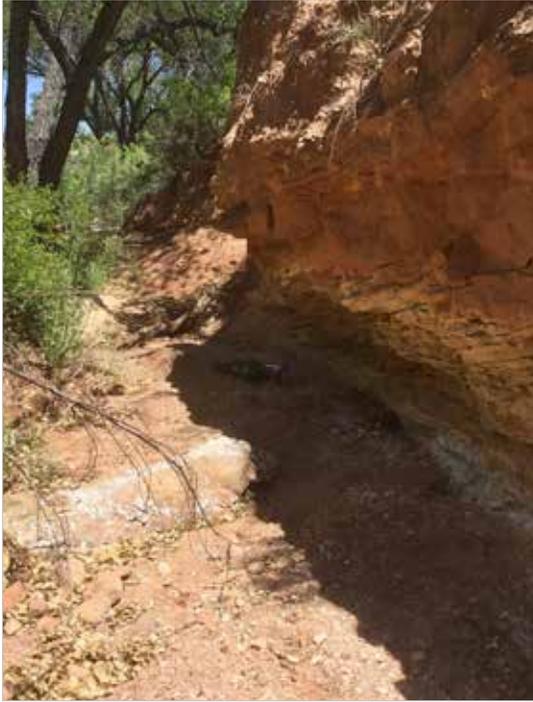
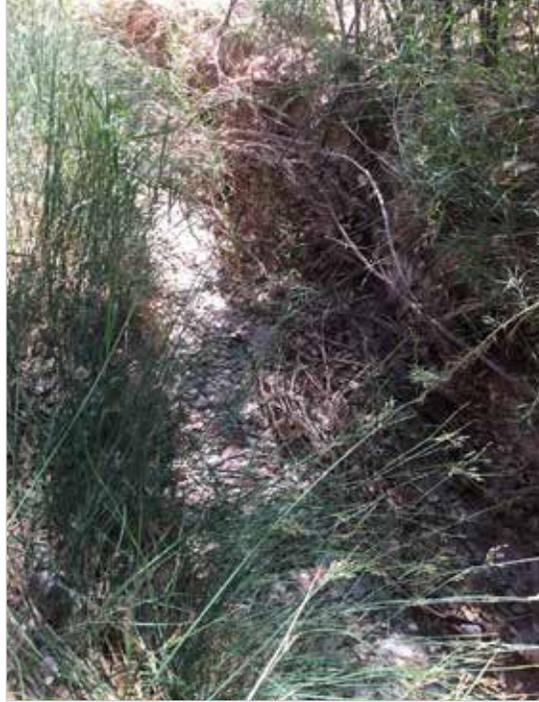
Spring 125 possible spring sources (both photos).

Site Condition: No surface water is present. The exact location of the spring is unclear. The terrace is about 3 feet high and has seen severe downcutting and erosion, which has likely affected the spring.

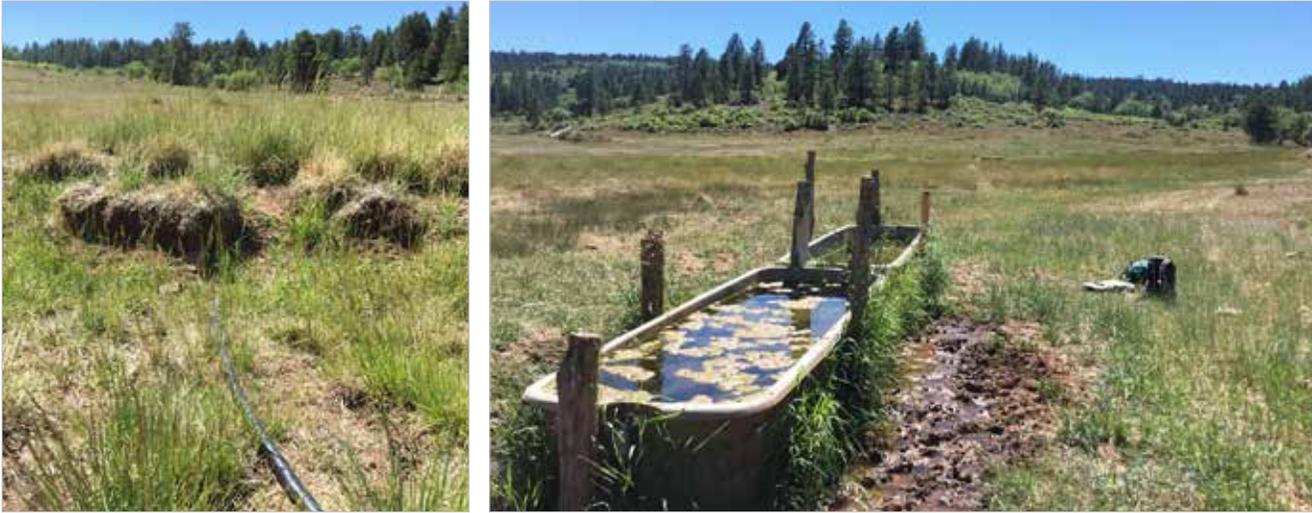
Spring 29 source (left) and water trough (right).

Site Condition: All the water is piped from the spring source to two cattle troughs which overflow and create a 12 foot by 100 foot wetland leading to a diversion. The pond is fenced from cattle, protecting some of the wet meadow, but not all of it. Elk trampling and heavy cattle trampling were evident from the source to the trough. Soil erosion and pedestals were observed.

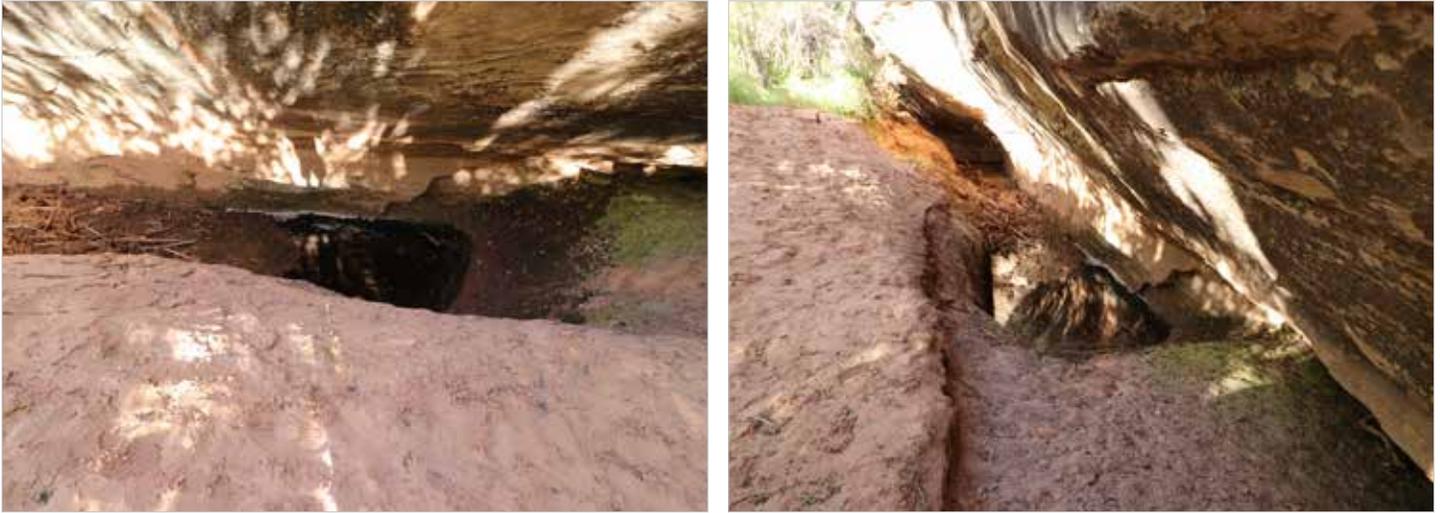
Step Canyon Blackwater Pool (left) and site overview (right).
